**BEULAH BRINTON HOUSE  
PRESERVATION STUDY REPORT  
JULY 2011**

**HISTORIC  
PRESERVATION  
INSTITUTE**  
School of Architecture and urban planning  
University of Wisconsin-Milwaukee  
P O Box 413-Milwaukee, WI  
53201-0413

This report was created as an academic document for the preservation of the Beulah Brinton House in Milwaukee, Wisconsin. The University of Wisconsin Milwaukee School of Architecture and Urban Planning's Historic Preservation Institute and its instructors are grateful to be offered this opportunity to instruct architecture students in the matter of building documentation, scholarly research, and preservation building design. We hope that the work completed will be an effective tool for the many people and organizations committed to saving this important local treasure.

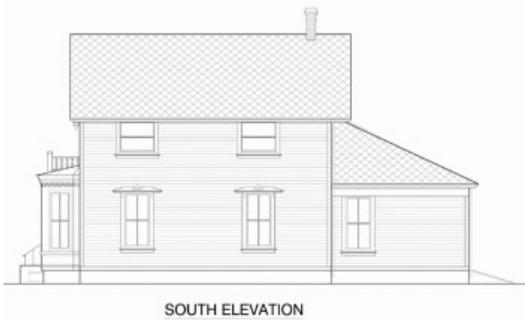
SOUTH ELEVATION

The west elevation, the most exposed public facade, clearly exhibits the fundamental features of the Victorian Gothic style. Window proportions, roof pitch, barge boards, window hoods, etc., all display the skillful craftsmanship of the original builder. However, historic photos indicate that the original front porch was quite different. Though the current porch occupies the same footprint as the original, it is classical revival in style with fluted, ionic columns and an accessible, flat, balustrated roof. The original porch was clearly Victorian Gothic with a pitched, metal roof, and Victorian, stylized columns and column capitals. These features are more clearly exhibited in the body of this document.

Though most of the windows seem original and consistent with Victorian Gothic, there were modifications to four second story windows. The historic photos show oval windows, two on the south and two on the west facades. At some point they were replaced with horizontally oriented, double hung windows, most likely for the extra light and ventilation that they provide.

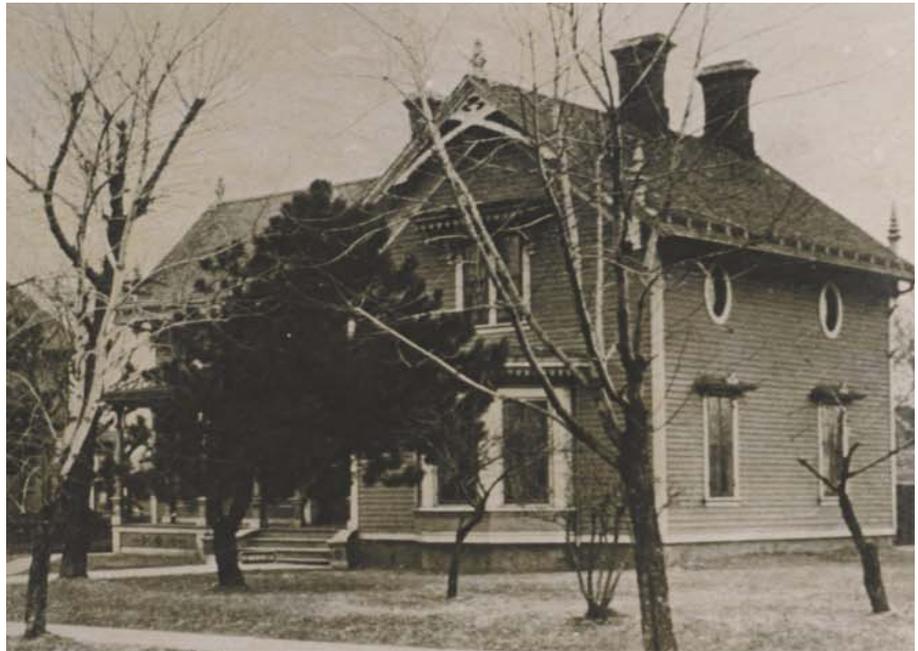
**SOUTH ELEVATION 1872**

Existing photographic documentation of the house, though limited, has been located and will be an important part of future restoration decisions. These photos show the house with some minor deviations from what we see today. The south elevation, to the right, clearly shows two prominent second story oval windows at each of the south bedrooms. These windows are an important character defining feature of the Victorian Gothic style. Though many other practical reuse needs will supercede the restoration of these windows, it should be considered an important part and an intelligent component of a proper restoration strategy.

Today the south elevation remains a highly exposed and important facade. Many of the original wood details of 1872 remain. However, the non-original, second floor double-hung windows are a clear contradiction to the decorative, vertical emphasis of the Victorian Gothic style. As older windows, they also have questionable thermal features. Strong consideration should be given to replacing them with oval windows that have operability and thermal performance qualities that reduce heating costs and restore the original stylistic look. This elevation will remain highly exposed and would be an important restoration statement to the community.

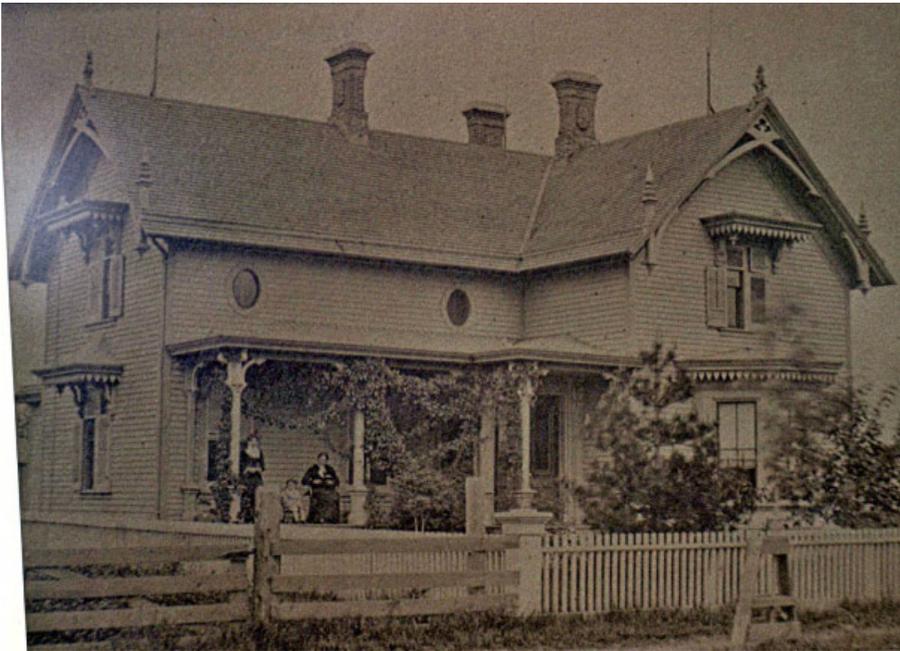
**WEST ELEVATION 1872**

The west elevation was historically, and remains today, the primary public facade and entry point. It was carefully composed to include many of the detail features that are expressive of the Victorian Gothic style. Details at the entry porch, in particular the decorative columns and column capitals, are very common for this particular style. The second story oval windows, also a part of this style, were consistent with the windows on the south elevation. Though these elements have been removed, much of the rest of the elevation remains in tact and should be carefully retained and repaired. Academic decisions about restoration of the porch and windows will be examined in this report along with the associated costs.

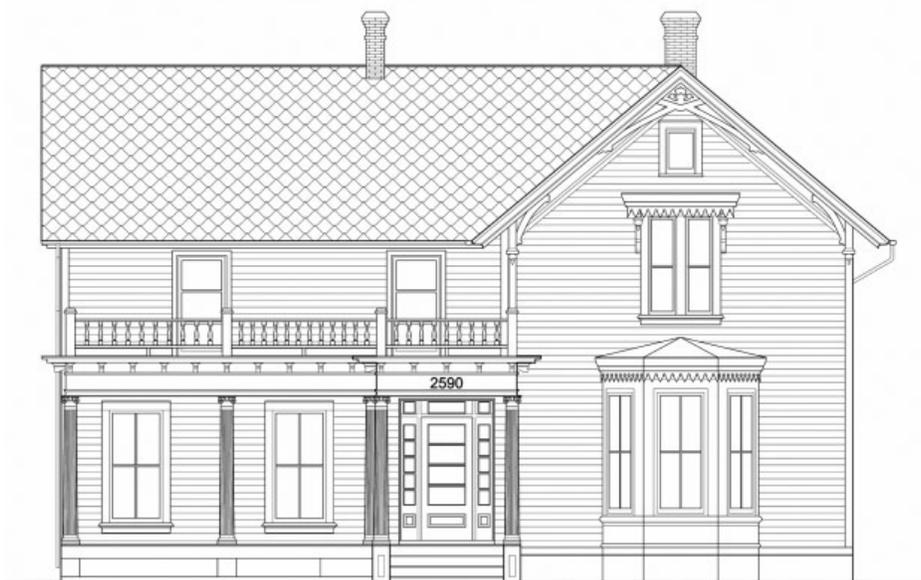
**WEST ELEVATION 2010**

The primary elevation has received rather significant modifications over the years, as illustrated to the left. It appears that several decades after construction, decisions were made to change the porch enclosure to a neo-classical look. Oval windows on the second floor were replaced with a double-hung window and a porch door, with columns changed to a fluted, ionic type shown to the left. Beyond the aesthetic aspect of this modification, it has also seriously deteriorated and repair is quite necessary. Should the work include repair of the existing or replacement elements with the more original Victorian Gothic look as illustrated above. This will become both an academic as well as a practical decision relative to its affordability.

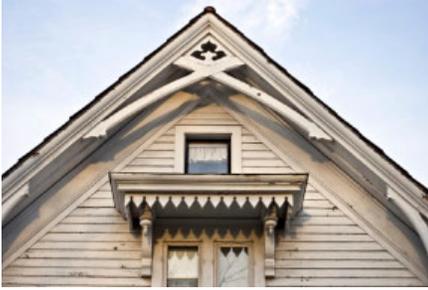
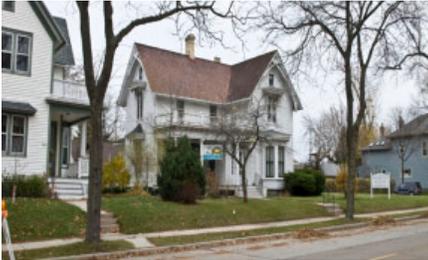
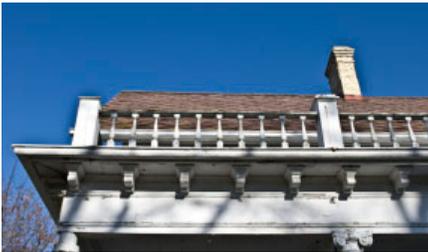
#### D. DESCRIPTION OF EXTERIOR

The Beulah Brinton House is located at the northeast corner of S. Superior Street and E. Pryor Avenue in what is known as the Bay View neighborhood, approximately three and a quarter miles from the Central Business District, along Lake Michigan. The property is approximately 152 by 101 feet in dimension and consists of two parcels, each with its own tax key. Each parcel is approximately 50 by 152 feet in dimension. The frame, L-plan, Gothic Revival style house is located on the north parcel and fronts west/southwest, sitting approximately 30 feet back from the sidewalk behind a grassy lawn planted with shrubs. The south parcel along Pryor Avenue is vacant, bordered by shrubs and serves as a side yard for the house. The surrounding neighborhood is residential in character with mostly one and two story frame houses of varying 19th and early 20th century styles including Italianate, Queen Anne and Arts and Crafts.

The Beulah Brinton House is clad in horizontal wood clapboards and sits on a brick foundation. The roof is sheathed with asbestos/cement shingles laid in a diamond pattern. Two chimneys rise from the roof, one at each wing of the house. The north chimney has reconstructed corbelling while the south chimney has been shortened. A small one story wing with hipped roof is located at the rear or east elevation. Windows are arranged to conform to interior spaces and consist of two-over-two sash on the first story and one-over-one on the second. A modern picture window with smaller sidelights is located on the rear wing.

The main or S. Superior Street façade is the most elaborate. The short wing of the L-plan is located to the right or south and parallels Pryor Avenue. Its gable end fronts the street and there is a three-sided bay at the first story. The long wing of the L-plan is located on the left or north and parallels S. Superior Street and has its gable end fronting north. A Colonial Revival Style porch with fluted ionic columns is nestled along the long wing and features a simple frieze and cornice articulated with modillions. It is topped with a wood balustrade consisting of turned balusters and square posts. The porch is skirted with wood, and metal grates fill in the openings. The entrance is located in the middle of the façade, in the crook of the L, and is brought flush with the plane of the short wing. It is framed by two free standing and two engaged fluted ionic columns. The door itself is a fifteen light door and is framed by five-part sidelights and a three-part transom. Gothic detail is concentrated on the front gable face of the south wing. It consists of bargeboard trim, a bracketed hood with saw tooth trim above the paired second story windows and saw tooth trim at the cornice framing the three-sided bay at the first story.

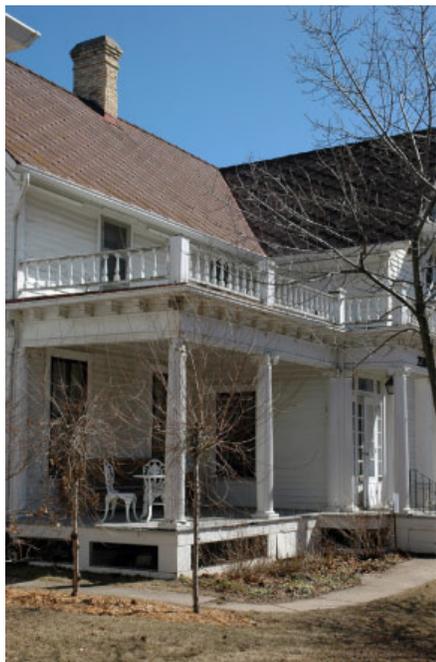
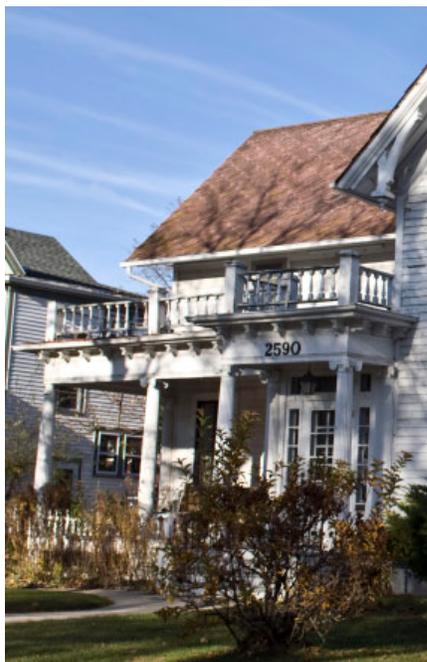
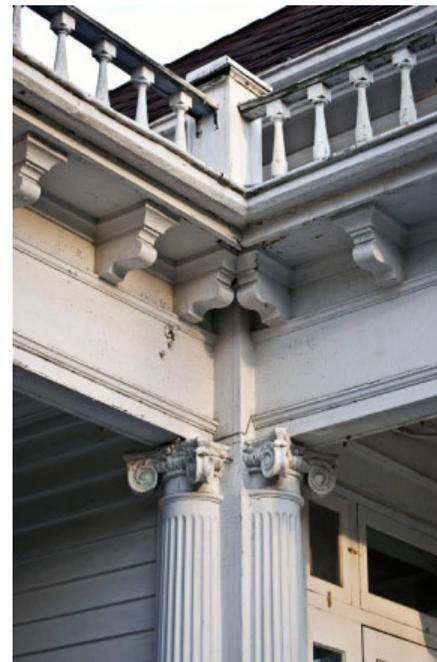
### ENTRANCE

The entrance is located in the middle of the façade, in the crook of the L, and is brought flush with the plane of the short wing. It is framed by two free standing and two engaged fluted Ionic columns. The door itself is a fifteen light and is framed by five-part sidelights and a three-part transom. Gothic detail is concentrated on the front gable face of the south wing. It consists of bargeboard trim, a bracketed hood with saw tooth trim above the paired second story windows and saw tooth trim at the cornice framing the three-sided bay at the first story.

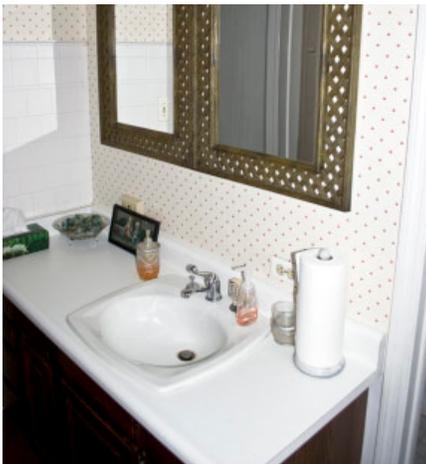
### PANTRY, VANITY & BATHROOM - 106, 107, 108

The pantry area and bathroom suite are the most problematic and difficult spaces on the first floor. As with most extant buildings from the 1870's the Beulah Brinton house's very survival resulted from changes to plumbing and electrical systems. In most cases updates were done insensitively, with expense being the guiding principle. For the Beulah Brinton house this was probably the easiest way to upgrade the bathrooms. Like the kitchen to the north, it is impossible to tell how this area looked originally. Nonetheless, it does seem as though this location, with its important connection to the large yard beyond and its great southern exposure, could have been better considered. Even if possible, we don't think that it's practical to try to return it to its original look. However, we do suggest that a design exploration take place that would explore techniques to create access to the yard (perhaps for the handicapped) done in a way that is sensitive to the Victorian Gothic look.

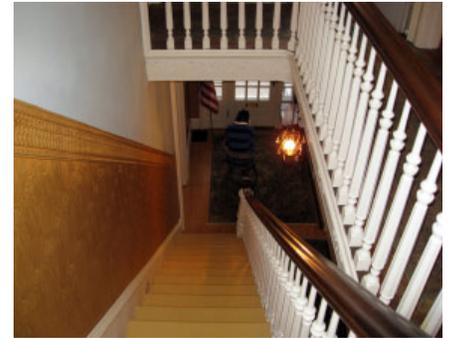
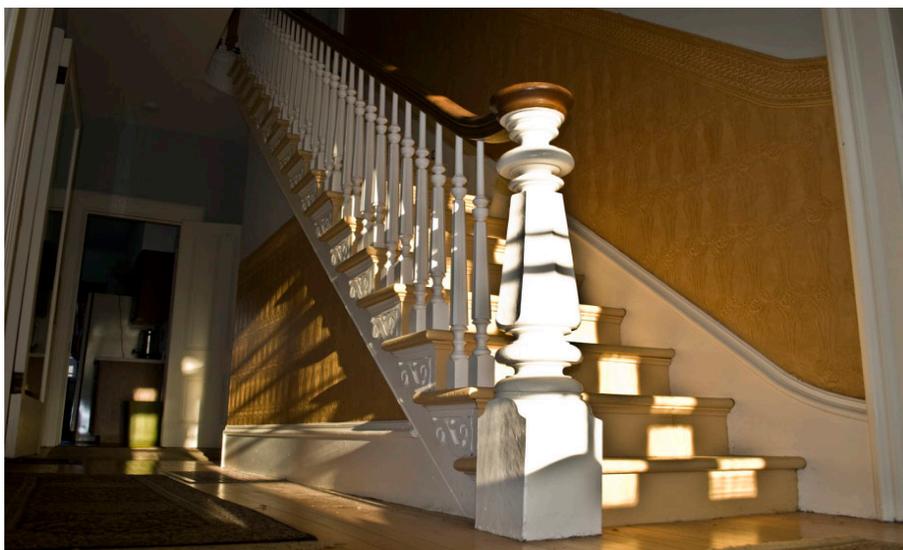
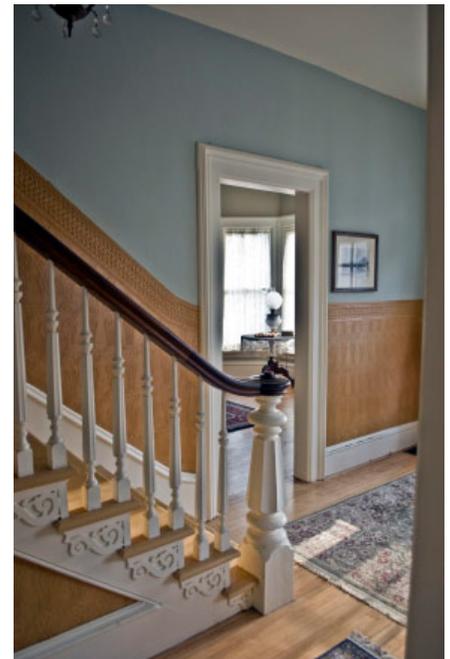
## MAIN STAIR 109

The main stair exists today as a historic jewel. The location at the front entrance positions it in a place of maximum exposure. The decorative turned newel post and spindles, the wood tread details, and the historic wainscot wall covering to the south all come together in a delicate and lacy exhibit of Victorian Gothic exuberance. The fine craftsmanship of the assembly is a terrific tribute to the carpenters who designed and constructed this feature. It surely was an element of pride and sophistication for the first occupants of the house and, through its excellent condition, seems to have been respected and cared for by subsequent owners. Physically it is solid and sturdy, and after 137 years, a testament to its fine craftsmanship and durable materials.

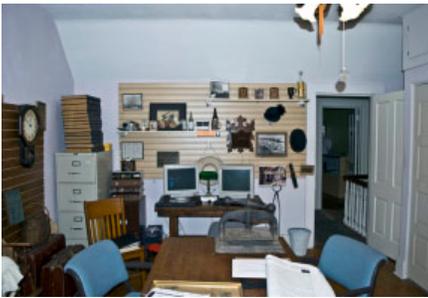
### ARCHIVE ROOM - 201

Certainly this room was originally a bedroom. The BVHS today uses it for its archives. However, in respecting the intent of this section to be a description of the original, we will consider it in this context as a bedroom. It is large and a bit more remote than the other bedrooms off the main stair. Perhaps it functioned as the master bedroom, though it's difficult to say with certainty. The bedroom to the north has an adjacent bathroom, but, of course, that wouldn't have been the case originally. So, it does seem possible that this was the master bedroom. It has excellent light and a view to the south and west and seems to have generous closet space to the east. Little has changed physically. Though electric was installed in the 1890's, the casing, flooring, walls, finishes, etc., all seem to be as they were originally. The window on the south wall was originally an oval and perhaps could be restored back to that appearance.

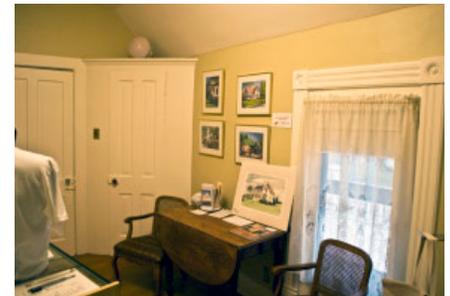
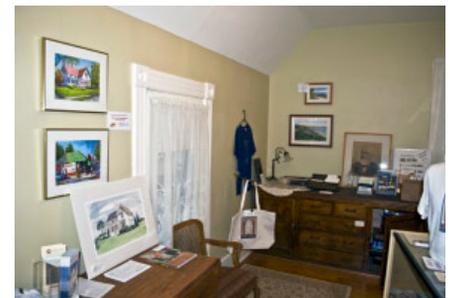
**SHOP - 202**

This room also was originally a bedroom. The BVHS today uses it as a giftshop. However, in respecting the intent of this section to be a description of the original, we will consider it in this context as a bedroom. It is small and a bit more remote than the other bedroom off the main stair, and perhaps it only functioned as an additional bedroom, though its difficult to say with certainty. As children were a likely component of early families, the small size of the space would not have been a major problem. Views and exposure west are quite nice, though today's accessible porch roof was actually a pitched metal roof originally, which would have restricted the view. So, not only was it inaccessible, but today's double hung windows on the west wall were actually small ovals windows originally. Consequently, the casework on the interior is not original.

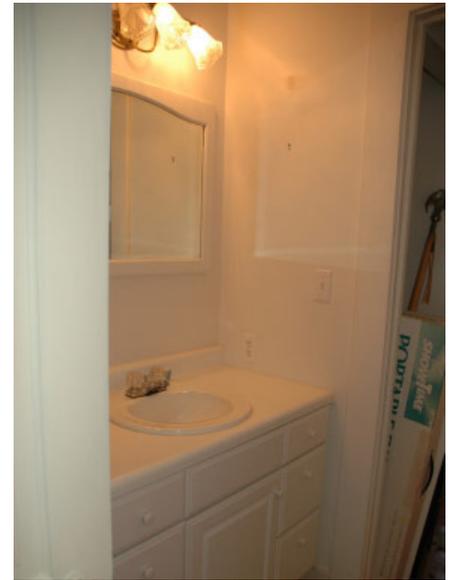
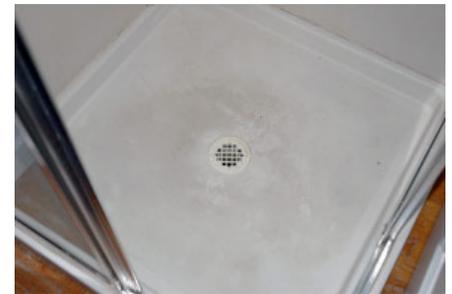
**BATHROOM - 204**

This bathroom suite is clearly a modification from the original. It's quite possible that in the 1870's it could have been a small bedroom, similar in size the room to the west. Indoor plumbing would have been highly unlikely then, and its doubtful that they would have devoted this much space to storage. There is a possibility that removing the remodeling work would expose evidence of what was originally there or how the space was used. However, it seems unlikely that such a restoration idea would ever become a strategy for the future use of the house. Returning the house to the 1870's does not seem practical, so having it continue to function as a bathroom space for residential or office purposes seems appropriate. Nonetheless, like the contemporary kitchen on the first floor, consideration could be given to making some minor changes to the fixture and finishes to make it seem more visually comfortable with the original house.

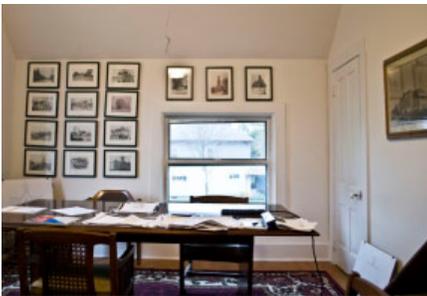
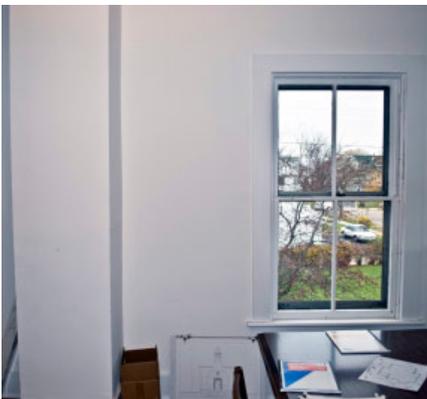
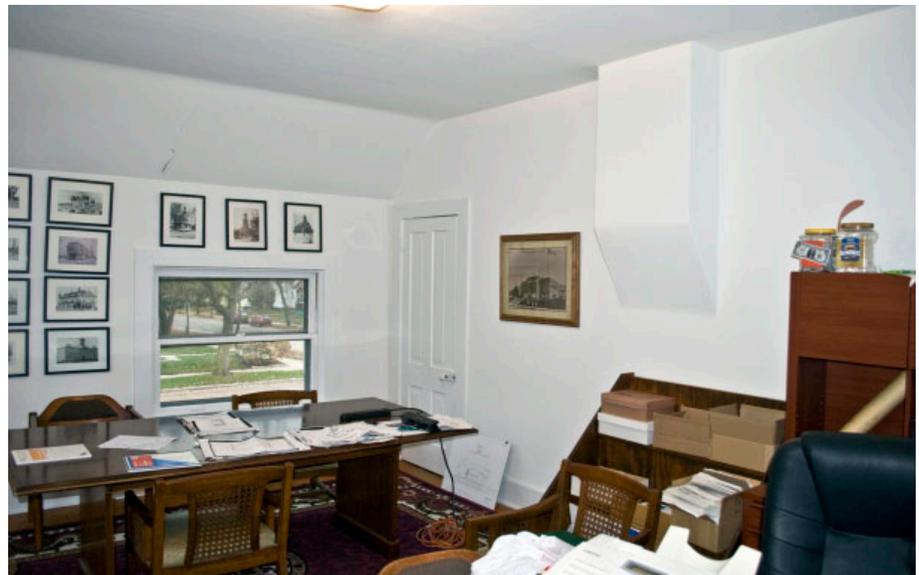
**OFFICE - 205**

This room was originally a bedroom. As the BVHS today uses it for other purposes, we chose to call it the southeast room. However, in respecting the intent of this section to be a description of the original, we will consider it in this context as a bedroom. It is medium size and easily accessible off the main stair compared to the other bedrooms on this floor. Compared to the other bedrooms, this room has great natural light and terrific views of the lawn below and Lake Michigan beyond. It seem that this has always been a very attractive room. It has only a small closet space to the west. We suspect that little has changed physically from its original look. Though electric was installed in the 1890's, the casing, flooring, walls, finishes, etc., all seem to be as they were originally. The window on the south wall was originally an oval and perhaps could be restored back to that appearance.

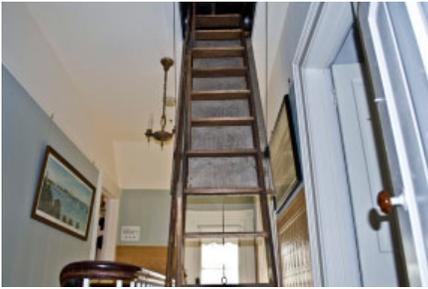
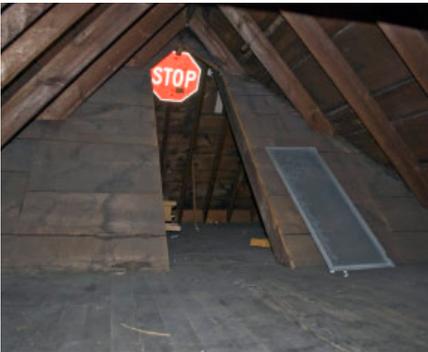
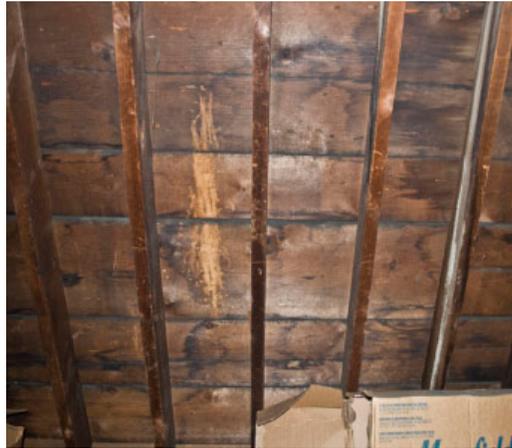
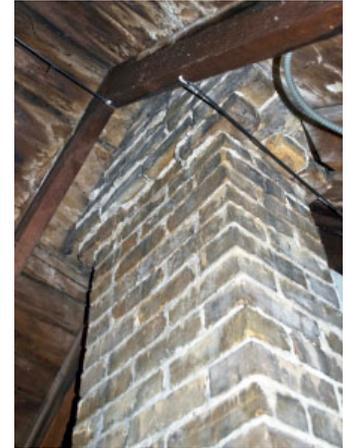
**ATTIC - 300**

The attic is an unused space covering the main footprint of the 'L' shaped house. It is vacant of both fixed and movable items. As such, it is an open space for viewable observation. Nothing unusual is exhibited with the roof framing members, but it is unusual and fortunate to have a complete hardwood flooring surface, making storage and accessibility quite convenient. The original masonry chimney locations can be ascertained and the openness will be helpful in examining for any future roof leaks. Clearly consideration should be given to installing new insulation with a proper vapor barrier.

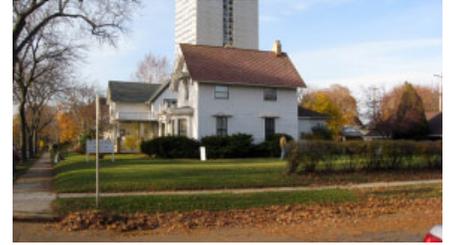
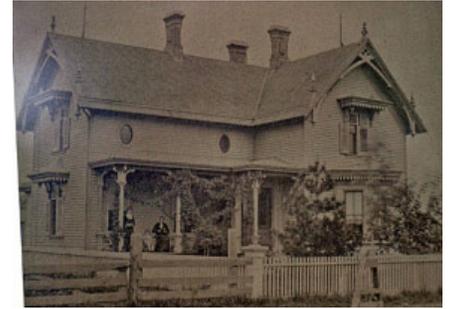
## A. CONDITIONS ASSESSMENT - SITE

The site remains in excellent condition. A broad open feel has been retained as was apparent in historic photos. The lack of trees or substantial shrubs has kept the viewing angles of the house open, facilitating high public exposure of the place. The openness has also assisted in surveillance and security. Historically, Beulah Brinton used the open area for social and recreational purposes, as originally a tennis court was located there. It appears, through historic records, that Beulah was quite generous with access to the place. No major fencing or restrictive landscaping was found, as was typically the case for the wealthy class at that time.

Some of the current shrubs cover up the base of the house, and should be considered for removal. Exposing the delicate base trim and detail was not only the original intent, but it also would help avoid the organic growth and associated watering needs that tend to deteriorate foundations. In general the site retains adequate drainage slopes to the perimeter. It appears that no significant costs will be required for site matters. The current openness promotes gatherings and display that were part of the original intent. Any new work should be focused on subtle modifications that might allow electric hook-ups, lighting, and perhaps areas of durable hard surface to facilitate public gatherings and use that may be difficult on grass.

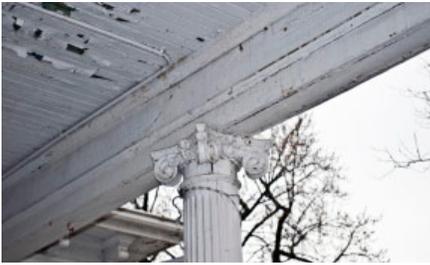
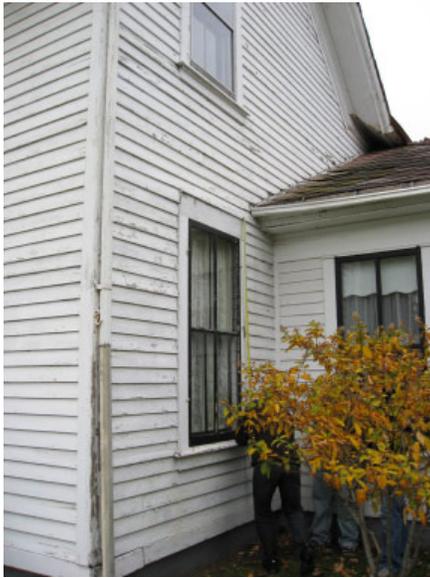
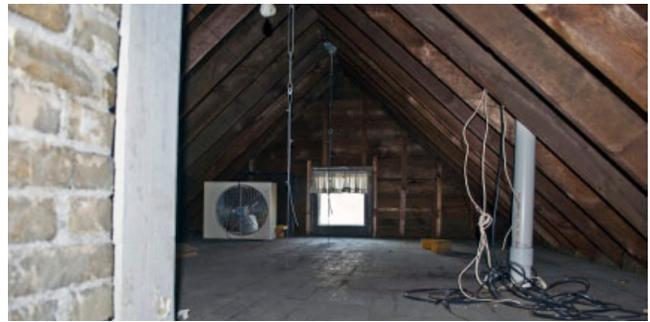
## B. CONDITIONS ASSESSMENT - STRUCTURE AND ENVELOPE

The Beulah Brinton house exterior is in reasonably good condition. An initial view suggests a high level of deterioration and decay. However, closer inspection shows a wood frame house in good structural condition with lots of 'cosmetic' deterioration like peeling paint, deteriorated roofing and non-original doors and windows. These features can be restored or replaced in a conventional way and represent maintenance matters that are expected for a wood frame house of this age. The wood features of the house, though deteriorated, offer a much easier and more inexpensive path to restoration than would a house of brick, stone, terra cotta, stucco, or metal.

Historic modifications to the house, like window replacements and the kitchen addition, will become more of an academic discussion about restoration and returning the house to its original look than a maintenance or conditions problem. The one feature that will be, however, a maintenance and authenticity issue will be the front porch. The current porch is both a departure from the original and it is also in bad condition. There is extensive rotted wood, open joints, and peeling paint. Restoring the porch to its original look may be expensive, but it will also be costly to restore it to its non-original, classical revival look.

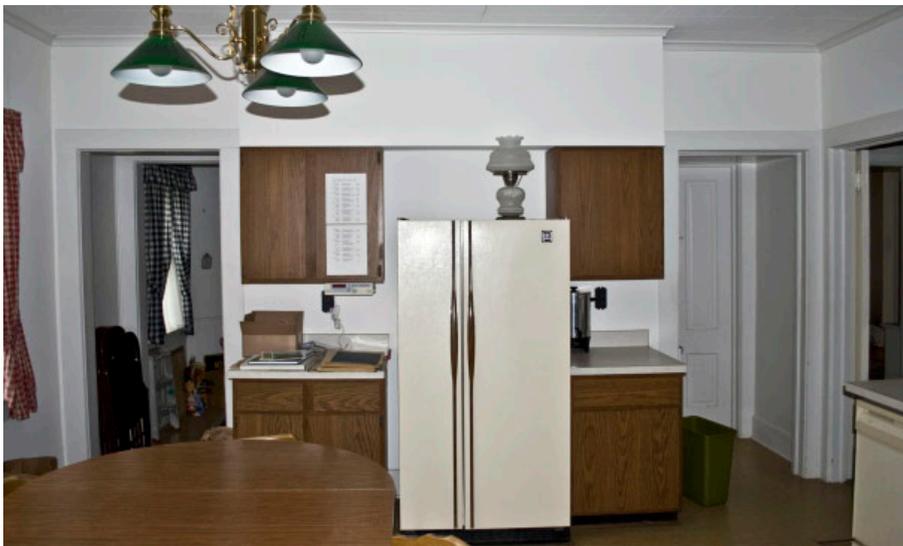
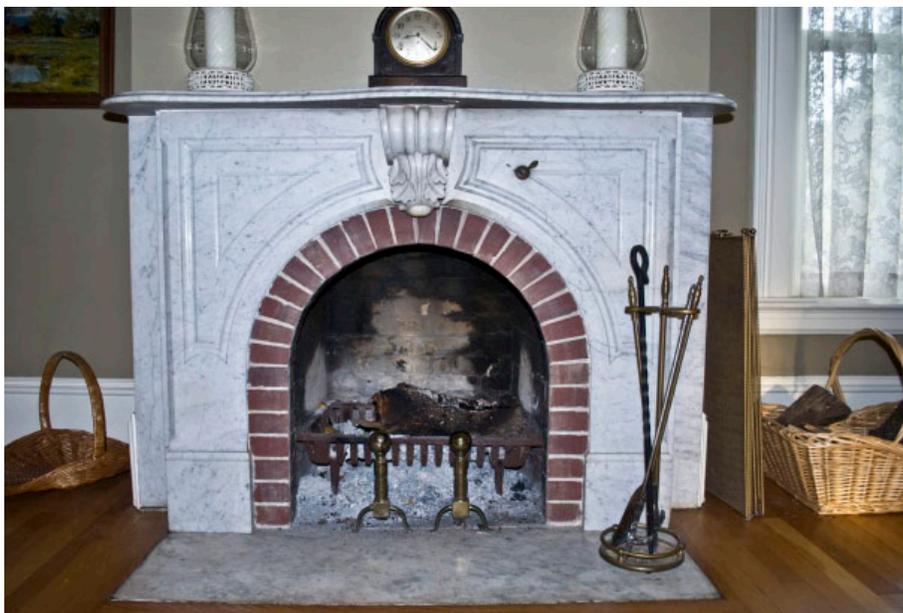
### C. CONDITIONS ASSESSMENT - INTERIORS AND SYSTEMS

As with the exterior, the interior is in reasonably good condition for a house this old. One can divide the interior of the house into a few general areas of condition assessment. The main rooms on the first floor are in excellent original condition. The entry, dining room, front room, and library are only in need of 'cosmetic' upgrading. The electrical systems are the only area of possible concern, but that evaluation is included herein. The basement is small and simple and has open accessibility to the systems.

The kitchen is the major area of concern. Though it 'works' properly as a 1970's era remodeling, it is a dramatic departure from the originality of the rest of the first floor. Clearly it needs no immediate repair or remodeling, but even if it isn't restored to its 1870's look, it probably should receive simple upgrades and modifications, particularly if revenue can be generated from it for food service functions for public gatherings. The second floor, like the first, has no immediate or emergency-type repair work needed. Office use of these original bedrooms seems to be the logical function for years to come. Simple modifications are described herein.

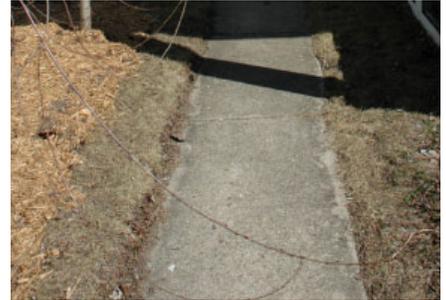
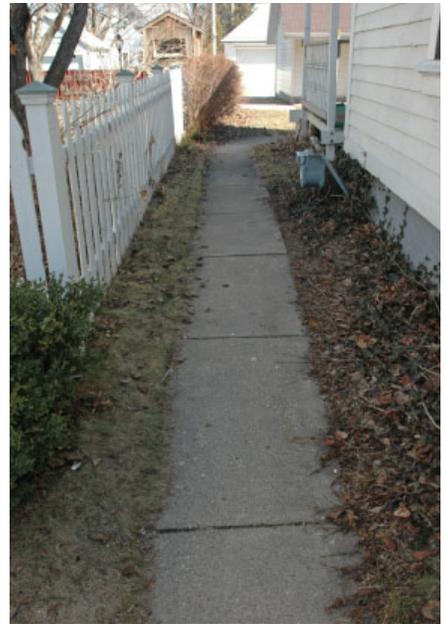
The paving for the site is concrete sidewalks and steps. Extending from the city sidewalk to the house is a concrete walkway with steps leading to the front porch as well as to the back door and garage. Most of the sidewalks and front steps are in good shape with a few cracks and stains. The concrete in front of the garage is extremely cracked and deteriorated and should be replaced.

- Patch and repair concrete at sidewalks
- Replace concrete slab in front of garage

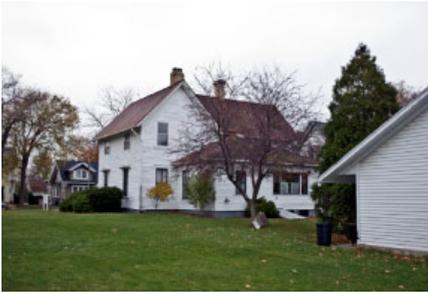
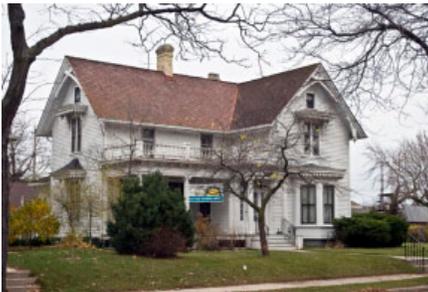
#### LAWN, SHRUBS, AND WALK SURFACE

The design features of a 'single family' residence are apparent in the existing landscaping. The site consists of a large lawn on the south side of the building with bushes lining the Pryor Ave and back alley edges of the site. Two evergreen trees mark the southeast corner of the site. The south and west sides of the house are lined by large bushes with planted flowers and vegetation in front of the porch. A large evergreen tree and a berry tree hide the southwest corner of the garage.

New landscaping modifications should stay humble in intent. Existing shrubs at the base of the house and foundation should be removed. Low, foundation friendly materials should replace the vegetation. Landscape companies should offer suggestions for hard, walkable materials for public gatherings that retain the green lawn feel. A program of maintenance and upkeep, which would include regular watering, weeding, and grass cutting, should be provided by the contractor.

- Remove bushes lining the western and southern side of the house
- Remove flowers and plants in front of the porch
- Provide hard surface for public gatherings
- Repair main lawn, provide lawn maintenance program

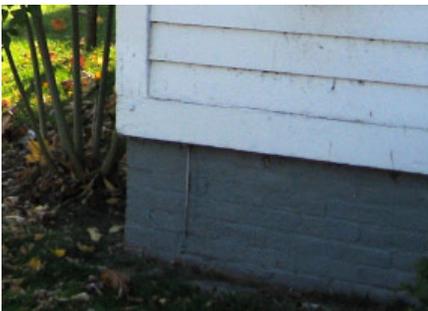
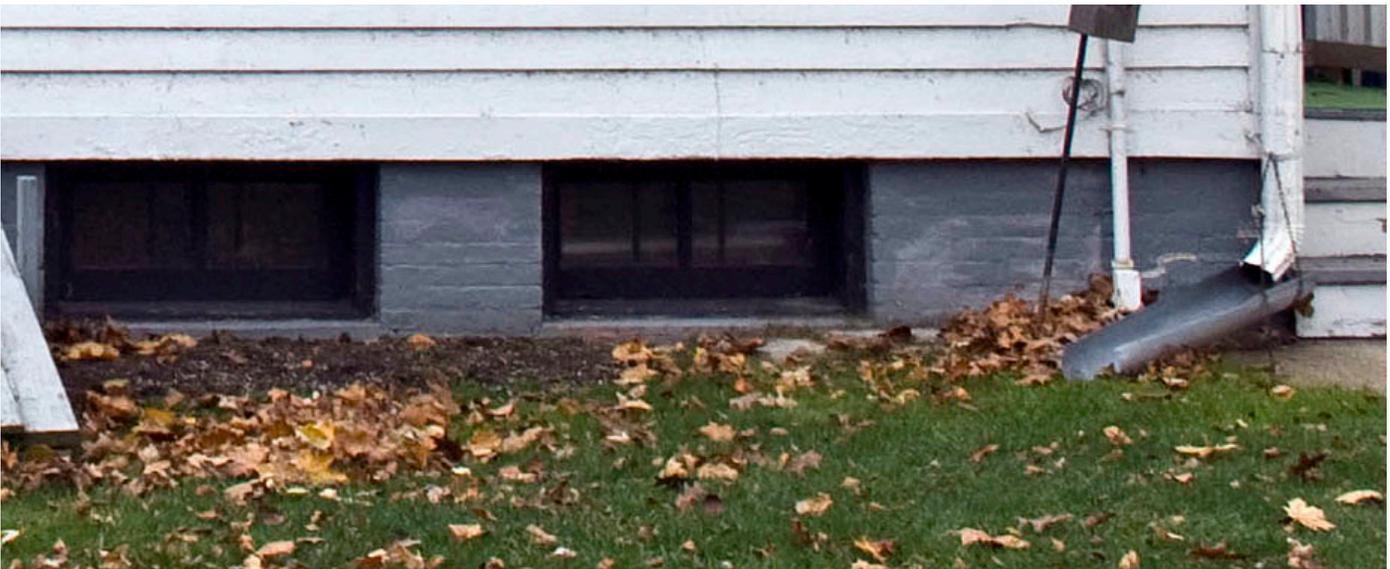
### CHIMNEYS AND FIREPLACES

The house has one main fireplace. Located on the first floor in the room of the original library, it gives the house an important original feel. For a relatively modest house, it serves as a focal point detail of elegance and sophistication. The original marble mantel and surround is in good condition. Some minor cleaning and caulking might be necessary, as well as an analysis and repair, if necessary, of the firebox and flue.

As stated before, the recommendation for all masonry restoration work is to contract separately – outside of conventional contract with a masonry subcontractor – to analyze all current masonry conditions. This approach is applicable also for the interior fireplace. It is an important feature and every effort should be made to reuse it and to ensure, through a professional, that it works properly.

- Tuckpoint and patch all existing chimney surfaces
- Replace severely deteriorated or missing original materials
- Finish only as recommended by masonry restoration contractor
- Contract for chimney flue inspection/cleaning for fireplace use in future

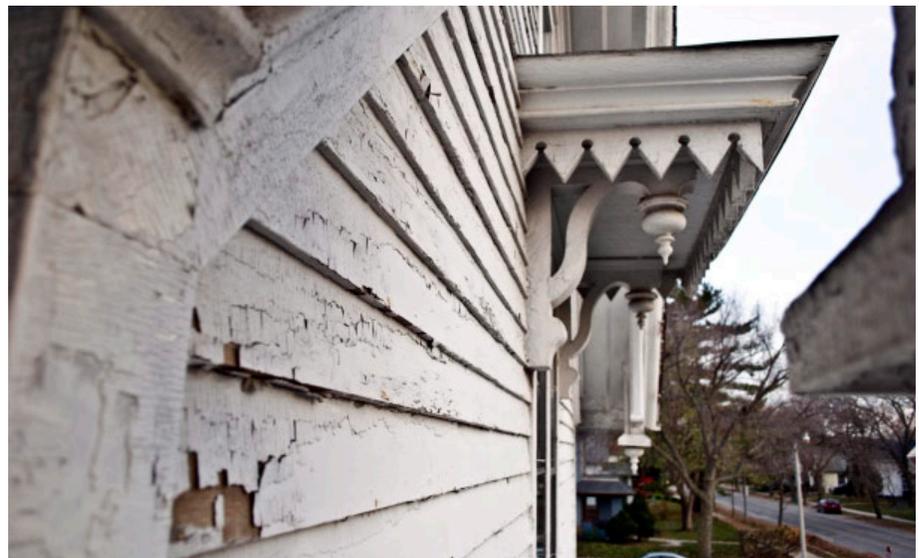
**EXTERIOR DECORATIVE WOOD ELEMENTS**

The exterior decorative elements are some of the most important features in establishing the Victorian Gothic Revival Style. The majority of the original elements are still present on the house. The bracketed hoods over the windows with spiky trim give added detail to the main north and west facades of the home. The first floor windows on the south facade include hoods with scrolled decorations above. The main decorative element is the gable ornamentation with elaborate bargeboards that are in good condition. The only decorative elements that are presently on the house that are not original to the Gothic Revival Style are the modillion articulated capitals of the fluted ionic columns lining the porch. The capitals are in poor condition and one column is missing the capital all together.

The recommendation is to repair all the existing decorative elements, replace the elements that show up in the historic photos, like the finials above the roof at the ends of the bargeboards, but leave, and repair the existing classical porch

- Remove all badly deteriorated wood features, replace with historically accurate
- Repair all existing decorative features - Replace like with like
- Restore all decorative wood elements per the historic photos

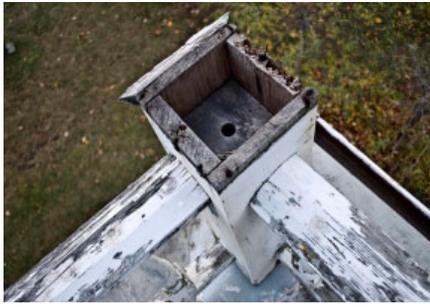
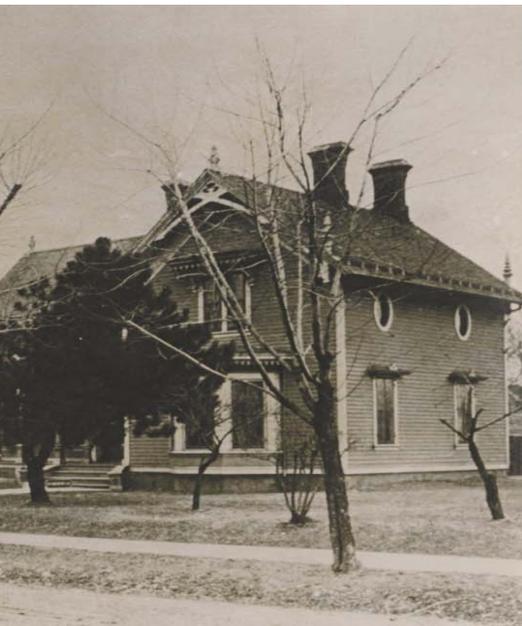
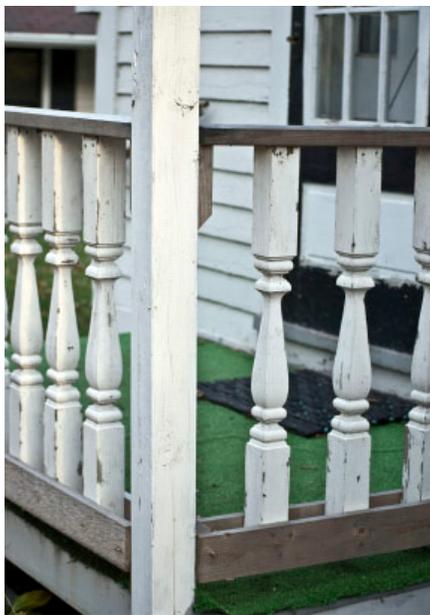
### EXTERIOR VICTORIAN GOTHIC PORCH RECONSTRUCTION

Though we recommend reconstructing the existing porch to the appearance of the original porch, that cost may be prohibitive. In the event that the existing is retained, significant work should be done to restore it. That approach is described and estimated on the previous page.

If however, the possibility exists to make a significant financial investment at the front entrance, we recommend reconstruction of the porch to the original appearance - several photographs exist that would aid in an accurate reconstruction. As an important symbol to the community, and a gesture about the commitment to an accurate restoration, this work would have a powerful impact. It could easily be a catalyst for raising additional funds.

- Replace porch balustrade with posts and turned wood of a Gothic Revival style
- Provide dimensions and design features that are code compliant
- Seal, prime, and make all features paint-ready

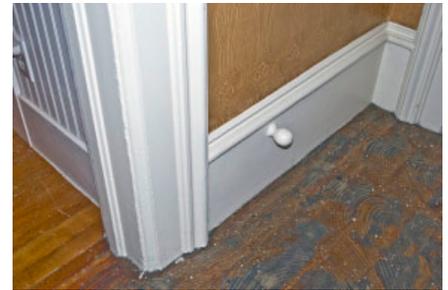
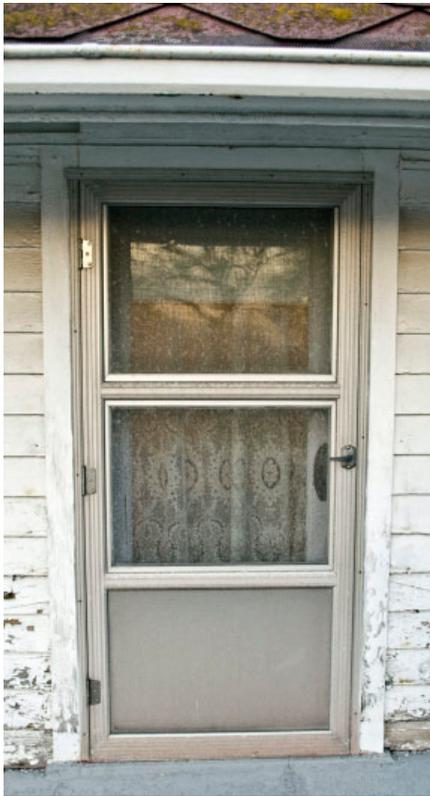
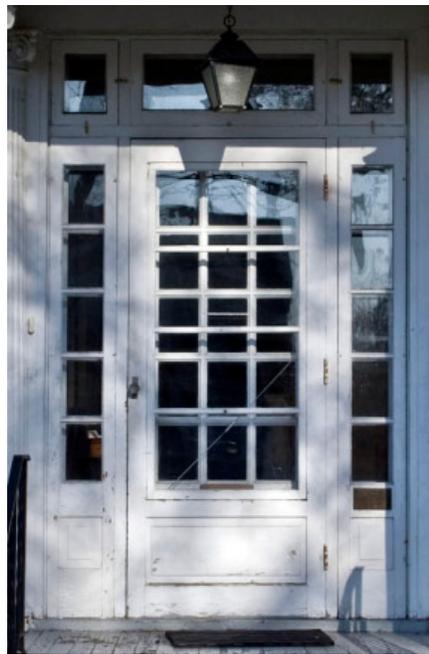
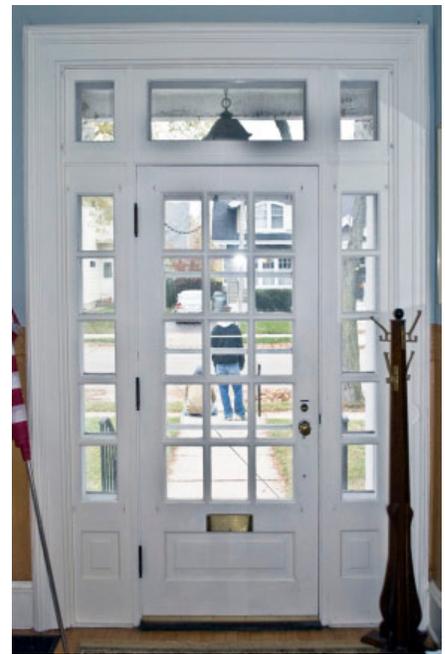
**DOORS - EXTERIOR**

The exterior doors of the house are in good shape. There are three exterior doors on the site. The most prominent is the main entrance on the western side of the house, which is a white painted wood door with 15 glass lights. It is framed by five-part sidelights and a three-part transom. This door is in good condition. The wood screen door on the outside is intact as is the interior glass door. A screw from the lock of the door has caused some damage to the frame, but, it is still structurally sound. The other main door to the house is the back door leading to the kitchen. It is a black and white painted door with six glass lights on the exterior with a six panel, four glass light, white painted wood door on the interior. Both of these doors are in good condition. The third door to the roof above the porch. This door is an aluminum screen door on the exterior with a glass door on the interior. This door is also in good condition even though it doesn't match the style of the main house.

- Scrape and repair existing wood doors
- Install new hardware where necessary

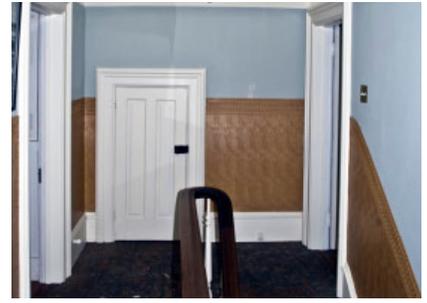
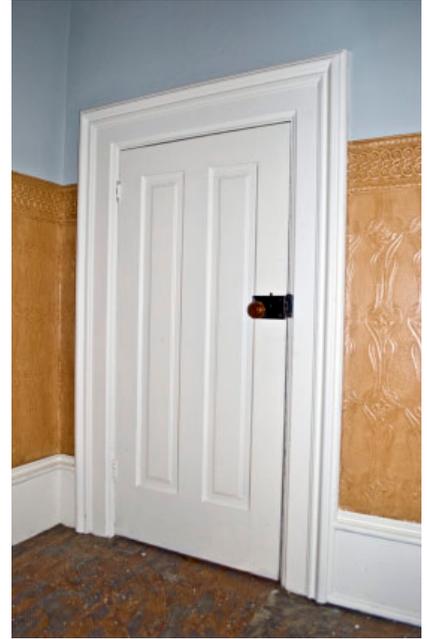
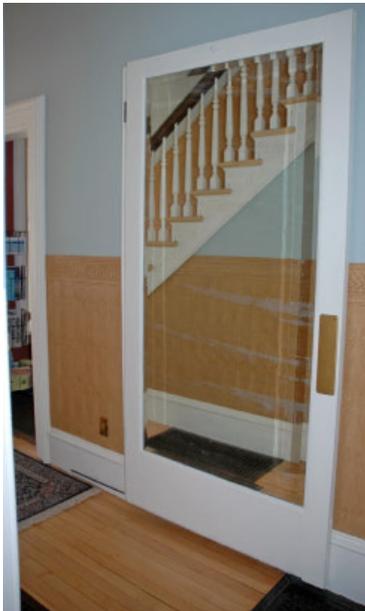
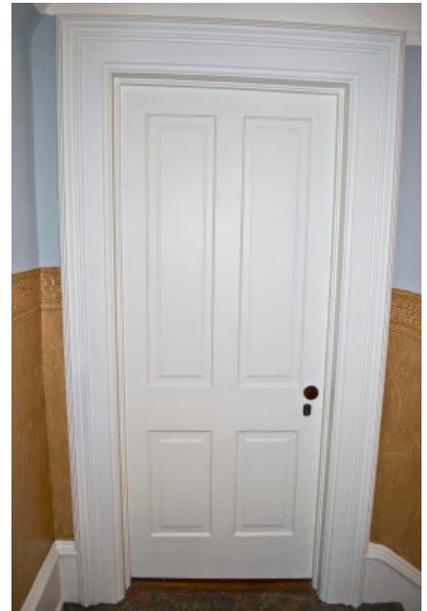
**SECTION 10: MILLWORK/DOORS/HARDWARE****DOORS - INTERIOR**

The majority of the doors in the interior of the house are original and in good condition. There are two major types of doors in the house, the standard door and the bi-fold closet door. The original standard doors of the house are four panel doors painted white. They are all in good condition and most have the original hardware. The two doors in the upstairs bathroom have modern hardware that does not match the rest of the house. Most of the rooms on the first floor do not have any doors. The vanity, bathroom, and kitchen are the only rooms that have the original four panel doors. The den, living room, and dining room are all without doors. The opening between the living room and den is large enough for double doors and may have possibly had pocket doors in this location. The second door type in the house is found in the Library. The closets in this room are covered by metal bi-fold doors that do not match the style of the house.

The existing historic wood doors should remain and be repaired where needed. The non-original doors at the bathroom locations on the first and second floor could be changed to accommodate new accessibility requirements. That cost would be dependent on the decision to proceed with the new layouts.

- Retain all existing wood interiors doors
- Retain and repair all original hardware
- Replace non-original hardware with hardware that matches original
- Provide new doors at missing locations to match historical doors
- Provide new wood doors and hardware in existing bi-fold door locations

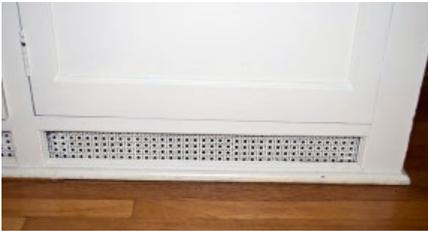
**BUILT-IN CABINETRY @ KITCHEN**

The built-in cabinetry at the kitchen is in good shape but not original, nor historic looking. There also are non-original cabinets in the den, vanity, bathroom, and back parlor/library room. The kitchen cabinets are of wood laminate and greatly contrast with the white painted wood of the rest of the house. The vanity also has a dark wood cabinet. This cabinet is closer in style to the rest of the house than the kitchen cabinets, but the dark wood contrasts with the white of the majority of the house.

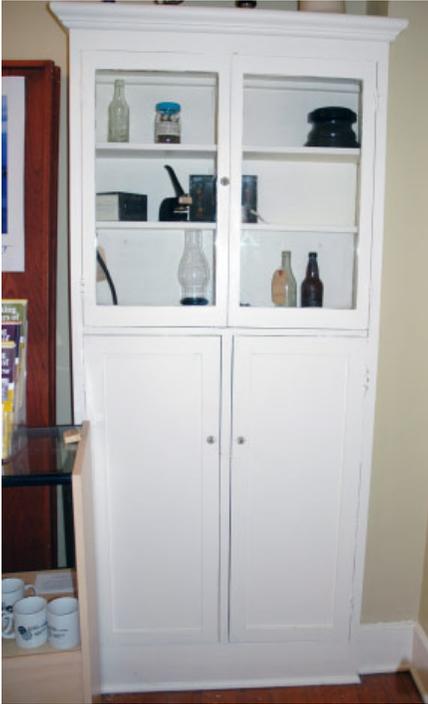
The back parlor (library) has a large cabinet and shelf built-in. The wood built-in is painted white to match the trim and moulding of the house. There is white painted lattice framed into the toe space of the built-in. The giftshop room has a pair of built-ins that flank either side of the doorway. These built-ins are white painted wood and are in very good condition. The giftshop has modern white built-ins. Even though these are not original to the house, they support the overall style of the home.
