**BEULAH BRINTON HOUSE  
PRESERVATION STUDY REPORT  
JULY 2011**

**HISTORIC  
PRESERVATION  
INSTITUTE**  
School of Architecture and urban planning  
University of Wisconsin-Milwaukee  
P O Box 413-Milwaukee, WI  
53201-0413

This report was created as an academic document for the preservation of the Beulah Brinton House in Milwaukee, Wisconsin. The University of Wisconsin Milwaukee School of Architecture and Urban Planning's Historic Preservation Institute and its instructors are grateful to be offered this opportunity to instruct architecture students in the matter of building documentation, scholarly research, and preservation building design. We hope that the work completed will be an effective tool for the many people and organizations committed to saving this important local treasure.

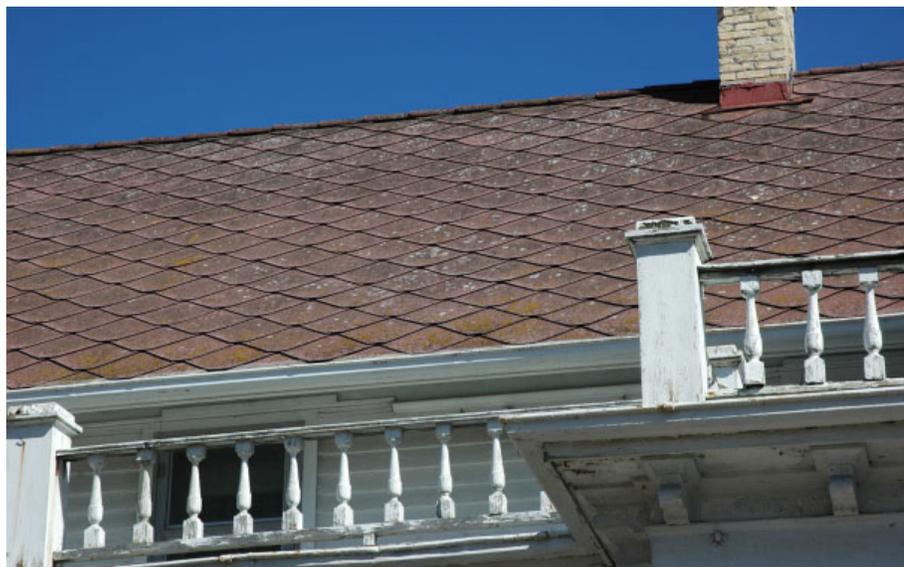
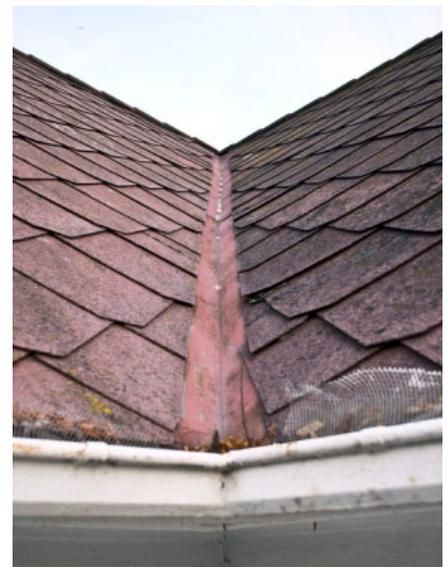
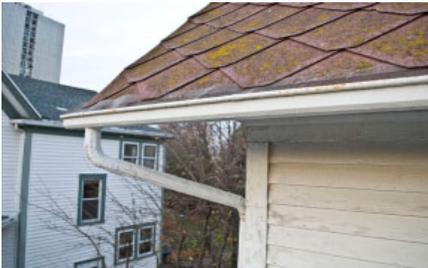
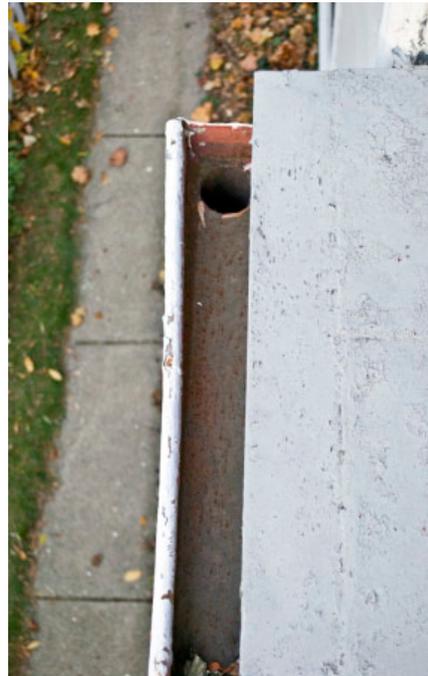
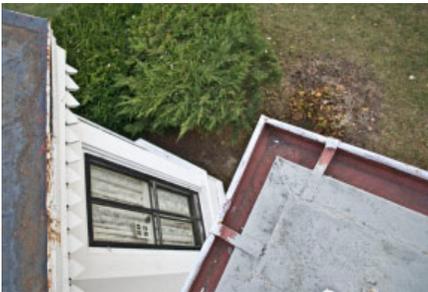
### GUTTERS

The gutters of the house are in fair condition. The white paint finish is not original to the house but it doesn't take away from the style and look. There are a few spots where the gutters are slightly bent and sagging. The downspouts around the house are in poor condition. Some of the downspouts have been partially replaced with sections that do not match the rest of the house. The downspouts are not original to the house, and although they do not take away from the look, some necessary repair and replacement is in order. Copper gutters and downspouts would be excellent looking and long-lasting and, with cash available, would be a terrific solution. However, understanding that the cost would be significant, an acceptable alternative would be a paintable, galvanized system.

- Replace damaged gutter system where necessary
- Provide galvanized downspouts and gutters on west and south facades

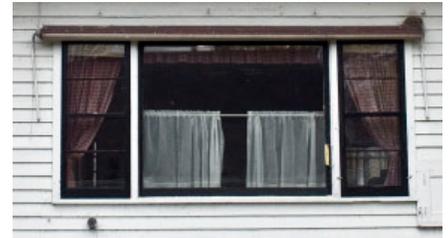
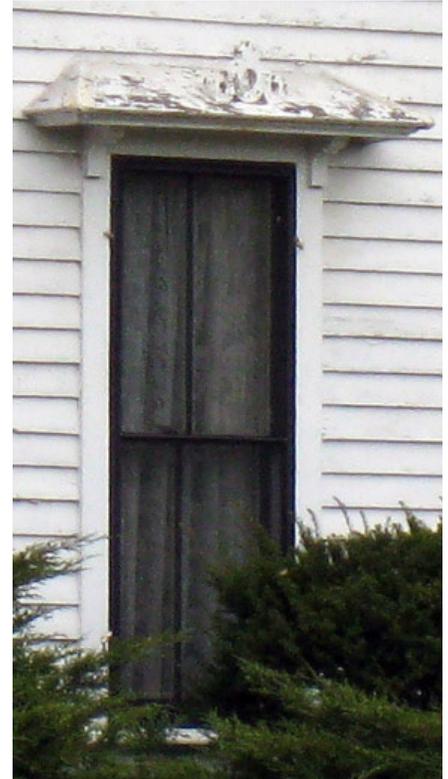
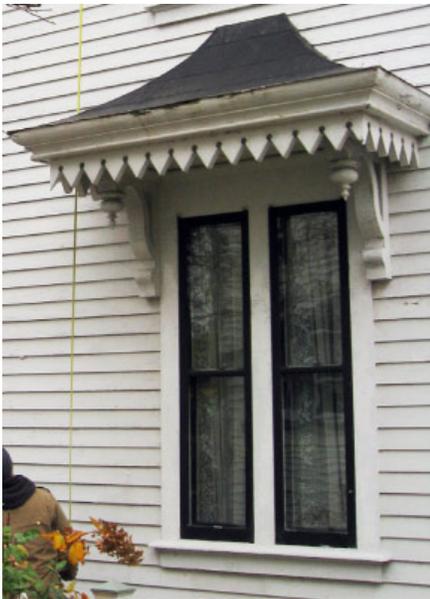
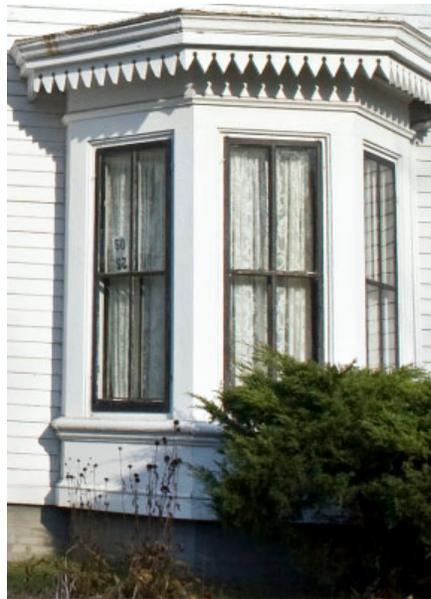
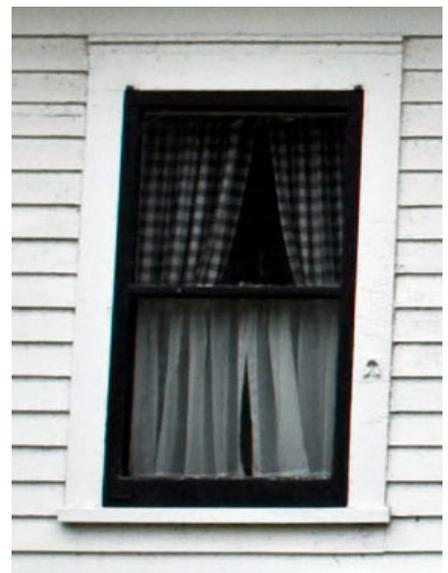
### EXTERIOR AND INTERIOR

The exterior windows are generally in good condition throughout the house. The first floor of the house has retained its original windows with wood storms and screens. There are a few small tears in the screens. The east side of the house has a large non-original, Chicago style window in the kitchen area. This window is not consistent with the Gothic Revival style of the house and the sash is in poor condition. The second floor windows have all been replaced. These windows are still in good shape, but the metal storm windows clash with the rest of the house. The windows on the second floor of the south facade are rectangular windows in contrast to the original oval windows that were removed.

We recommend repair work on all the windows with the idea of retaining as much as possible. This might include caulking, hardware, counterweights, etc. All windows and storms should be primed and prepared for a final painting by the painting contractor. Though no major replacement needs to happen to the first floor windows, we do recommend a major change to the second floor windows that would remove the non-original double hung windows and replace them with oval windows to match the original. This will require major carpentry work which would be included in the carpentry cost. This category is only for the window units.

- All efforts should be made to retain the original wood windows
- Clean original wood windows, repair, and paint trim
- Install new oval, operable wood windows on second floor

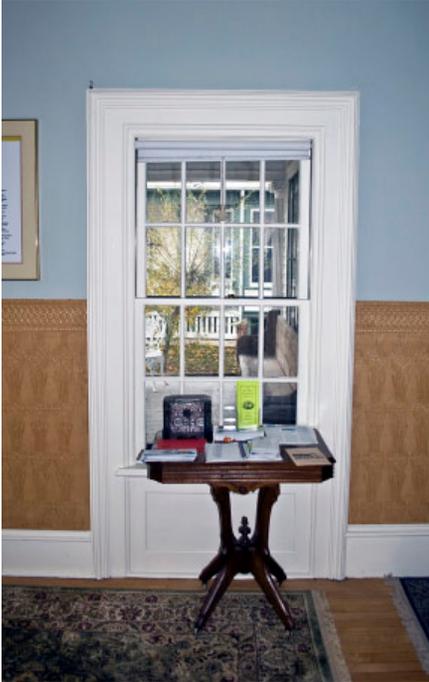
### INTERIOR WINDOWS

The only real case of an interior window is where the dining room and kitchen meet. The west wall of the kitchen seems to have been reconfigured in a way that makes it difficult to understand how it originally was. Also, there seems to have been a door to the back porch where a window now exists at the northly point of that wall. The other cased openings in that wall provide a 'pass-through' type of opening to the kitchen. Short of removing the plaster to inspect the studs, which we don't advise, it's difficult to understand exactly how it originally was. The current kitchen cabinets and counter arrangement have blocked entry to the dining room.

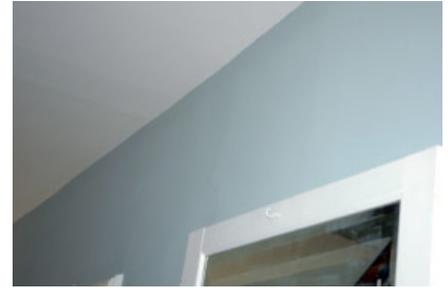
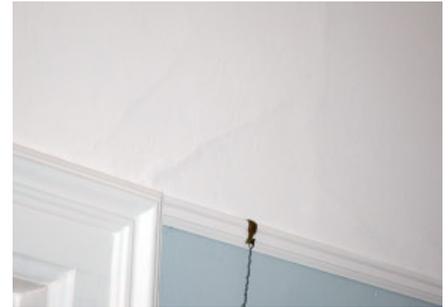
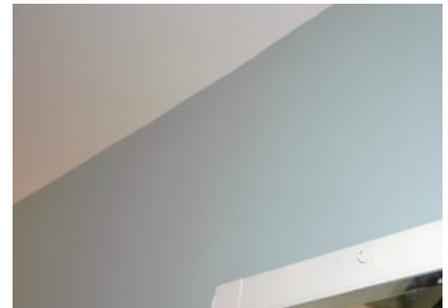
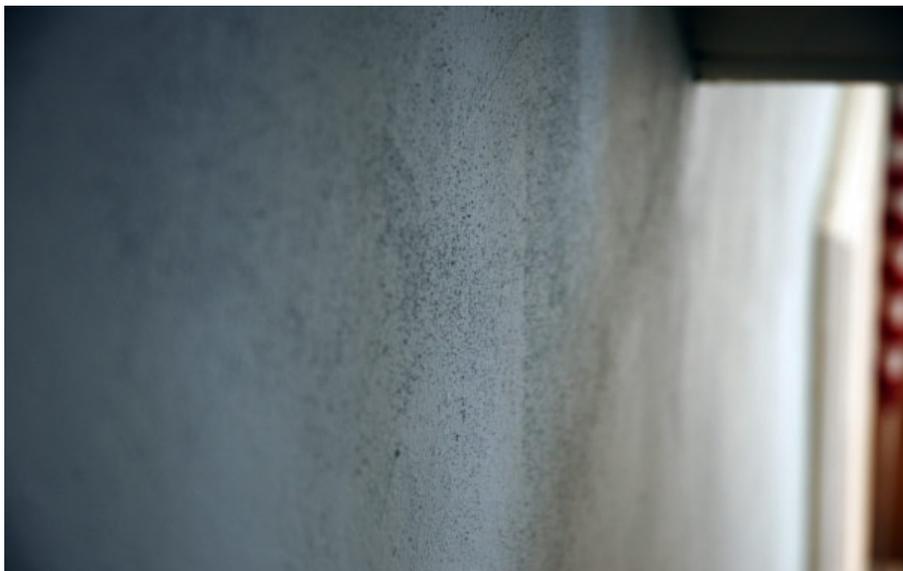
**SECTION 14: DRYWALL AND PLASTER FLATWORK**

The plaster in the house is generally in excellent condition for its age. It is clear there have been recent repairs and painting in many areas. There are some notable defects however, and the following are observations concerning individual rooms:

The front entrance/hallway is in great shape including the ceiling. There is some need for repair on the decorative plaster (see Article 14, Decorative Plaster). The dining room is in great condition. Minor problems were noticed on the east wall between service openings. There are small holes from hanging picture. On the north wall west of the window there are screws on the wall that should be removed and plaster patched. The ceiling is in good shape though it's clear there have been recent repairs.

The front parlor is also in excellent shape with some small indentations on the south wall, while the ceiling looks good. The back parlor/library is in good shape with only small indentations over the fireplace and south wall. The main stair is in good shape, see Article 14: Decorative Plaster for information on minor problems. The second floor hallway looks good. Everything has been kept up well. The giftshop also needs no repair work. The upstairs bathroom is a non-original renovation and the wall material is drywall. Everything looks to be in good shape. The kitchen is non-original, but is in good condition.

- Clean and repair plaster on wall and ceiling surfaces.
- Contract out for complete analysis of original plaster details and color palette.

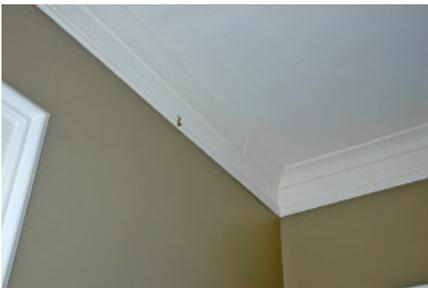
### SECTION 14: DECORATIVE PLASTER

The decorative plaster in the house is generally in good condition, with recent repairs and painting. There are minor defects however, and the following are observations concerning individual rooms:

The front entrance/hallway is generally in great shape, defects were noticed on the north wall between the dining room door and the window. There is a hole in the decorative element and a small paint splatter from the paint job above. On the north wall adjacent to the front door the decorative plaster is cracked. On both the north and south wall, adjacent to the front door, the plaster element is bowing a little off the wall at the joint of each adjoining piece. No immediate repairs are needed, but future consideration should be given to repairing this detail. The main stair is in good shape, but there does appear to be minor bowing of the decorative plaster trim. The Second Floor has fewer decorative pieces and appears to be in good condition.

Decorative plaster touch up. ....\$5,000

- Restore decorative plaster in first floor and second floor hallways to their original appearance (materials, decorations and colors).
- Inspect and repair of all existing decorative plaster.
- Contract out for professional analysis of original color palette and finishes.

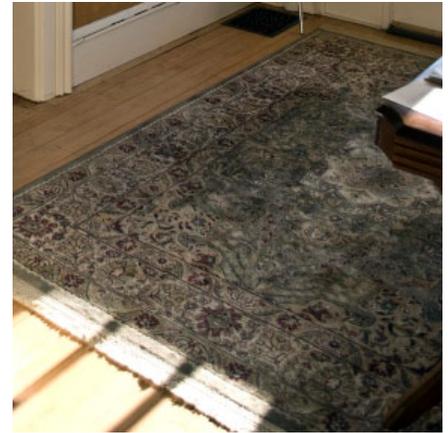
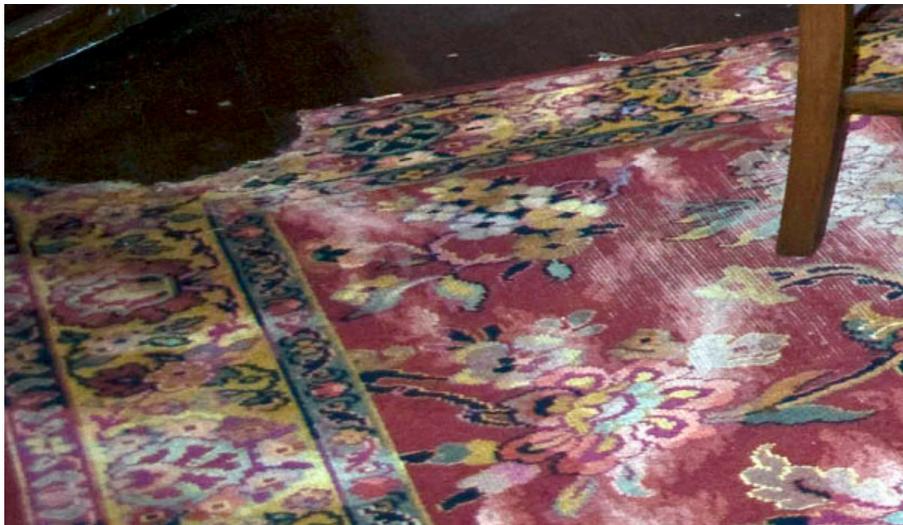
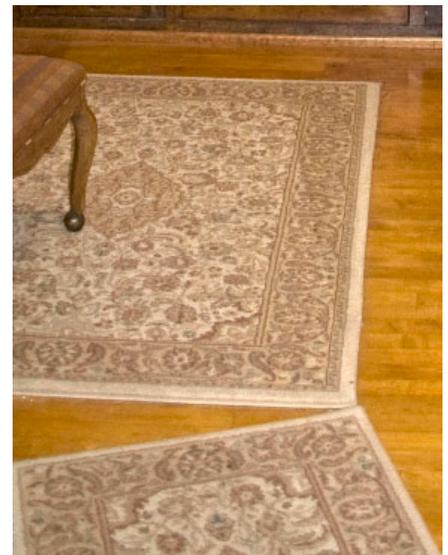
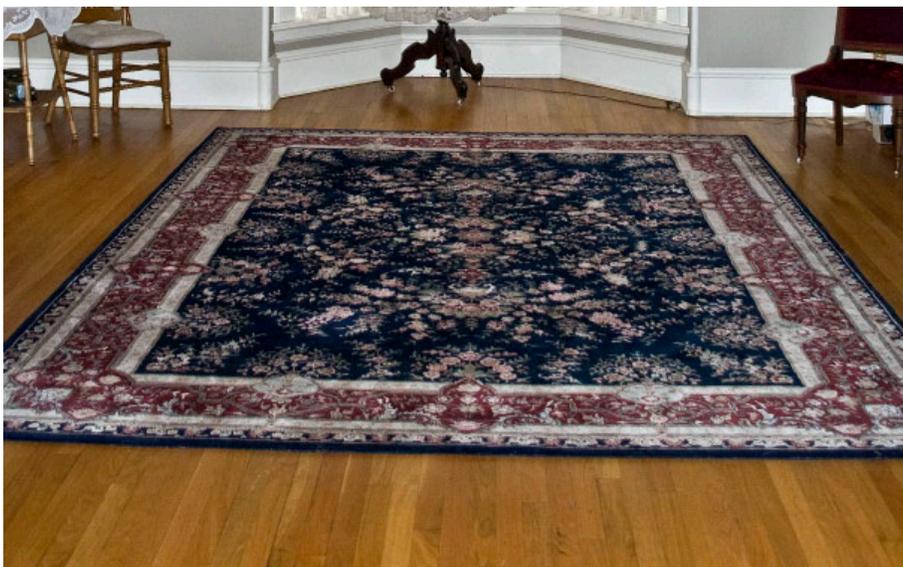
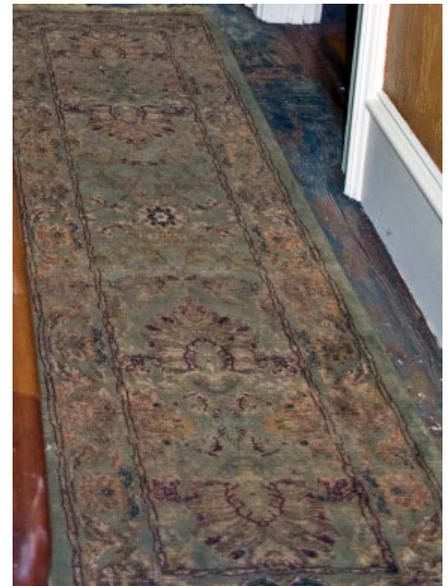
**SECTION 16: CARPETS**

Some of the carpets are showing signs of wear, although oriental-style carpets with the patina of age are in keeping with historic decor. Though replacement isn't immediately necessary, some allowance should be made for future replacement. The main stair could use a carpet and the dining room carpet is in need of immediate replacement. Carpets have a strong visual impact along with being an important protector of the hardwood floors which are in excellent condition at the moment.

Carpet allowance and recommendations ..... \$4,000

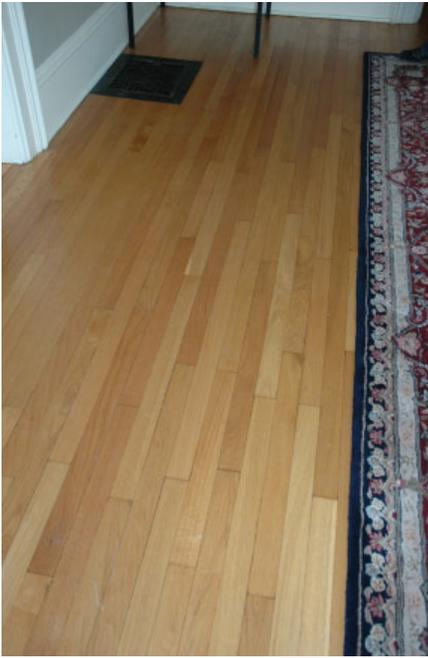
**SECTION 18: WOOD FLOORS**

The wood flooring in the house is generally good, with only a few areas needing refinishing due to inconsistent use patterns and scuffs from basic wear and tear. The exterior wood decking needs to be replaced immediately.

The front entrance/hallway is in good shape with only minor scuffs in the finish. The board next to the south wall adjacent to the front door has separated a bit and is bowing. The board next to the south wall adjacent to the closet under the stairs needs to be replaced - it has bowed and cracked. The entire floor needs to eventually be refinished. The color is not original. Refinished, it should match the hue of the dining room. No repair is required immediately, but it should be in the plans for the future. The dining room is in good condition. However, there are white paint splatters on the floor and there are some scuff marks from dragging furniture. No repair is required immediately, but should be in the plans for the future.

- Completely replace exterior stairs and porches
- Repair hardwood floors on the second floor, especially the hallway.
- Sand, repair, and stain/seal all hardwood floors.
- Retain all hardwood floors.

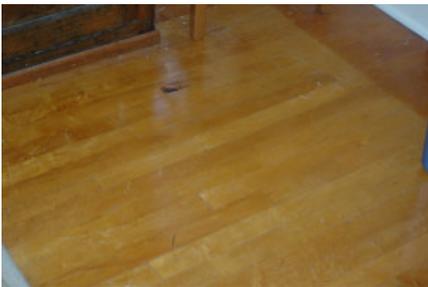
The rear parlor/library is in excellent shape. There are some minor scuff marks from furniture. Also, the floor should eventually be refinished to match the original hue in other rooms. The giftshop is similar to the living room. The main stair is in good shape other than some scuffmarks. No repair is required immediately, but it should be in the plans for the future.

The second floor hallway wood flooring is in good condition. There are minor paint smears, and marks that indicate that there was some type of covering (they are in a circular pattern covering the entire floor surface). The giftshop is in good shape, no repair is required immediately, but should be in the plans for the future. There must be immediate attention to the exterior wood decking. The porches and exterior stairs need to be replaced due to rotting wood. The finish on all of the hardwood floors in the house is inconsistent. It is recommended that they be restored to their original finish.

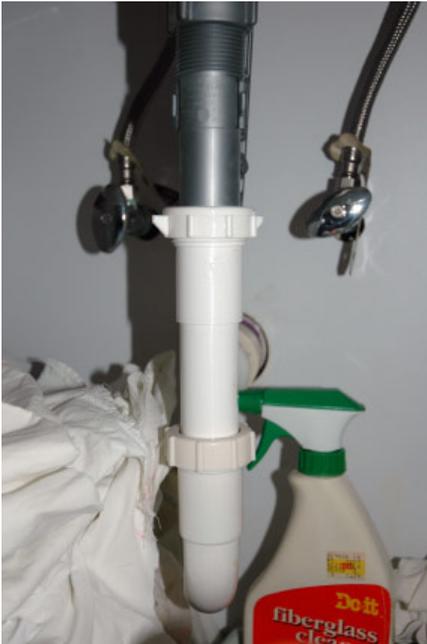
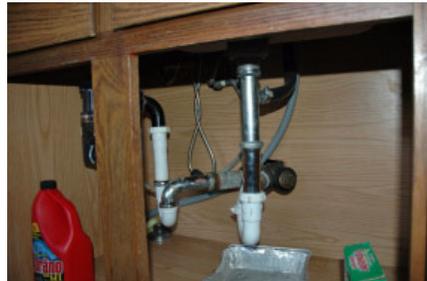
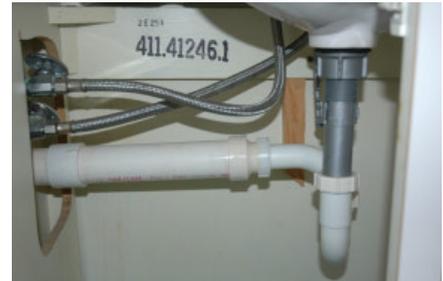
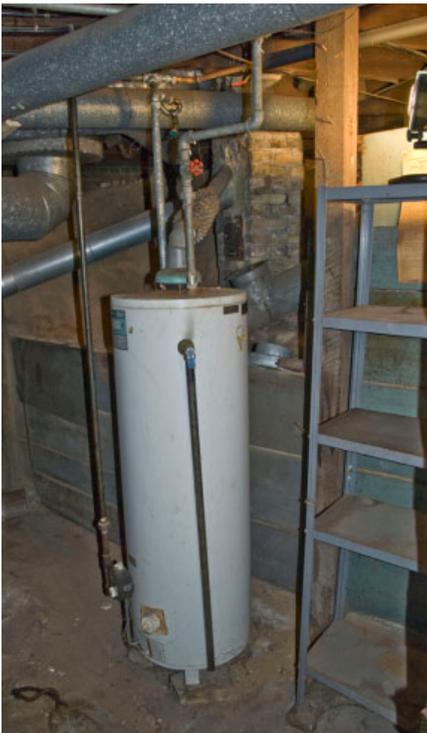
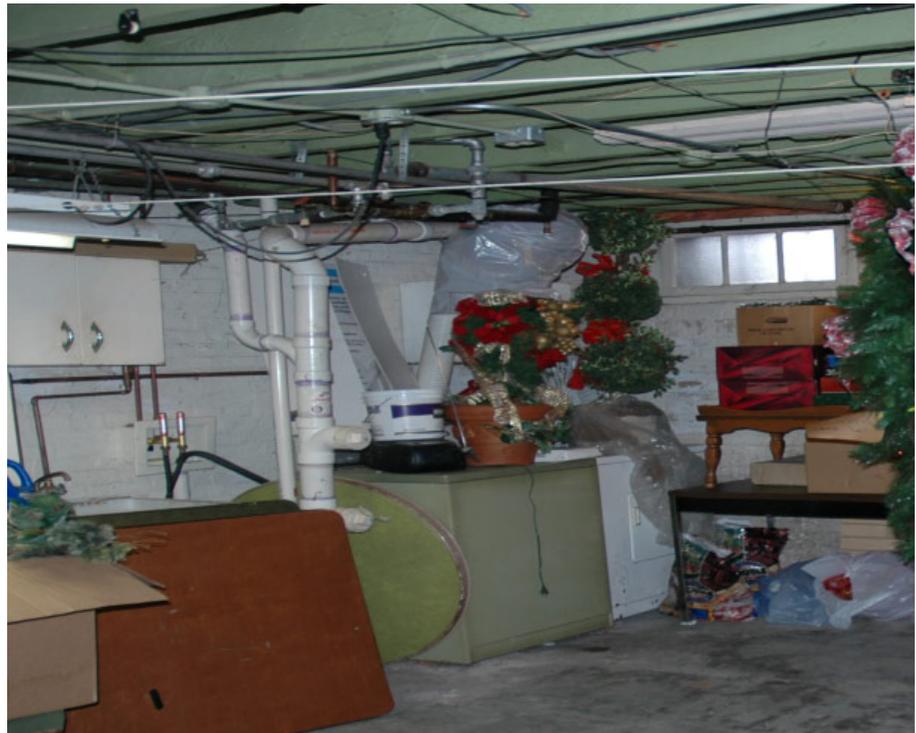
### SECTION 23: PLUMBING

The plumbing seems to be good throughout the house. However it is recommended that the water taps be opened and run every week or two to be sure the pipes are good. The fixtures should have routine checks for leaks. The non-original renovation to the kitchen sink looks like it is in good shape, however it seems that there have been problems in the past with leaks beneath the sink. The non-original downstairs bathroom is in great shape. All of the faucets work well and the toilet flushes well. The tub could use a resurfacing though. The non-original upstairs bathroom is in good shape. The faucets work properly and there have been no indications of leaks.

- Completely replace any leaking fixtures.
- Evaluate existing piping, domestic and sanitary, for any problems.
- Provide plumbing work estimate for remodeling of first and second floor bathrooms and kitchen.

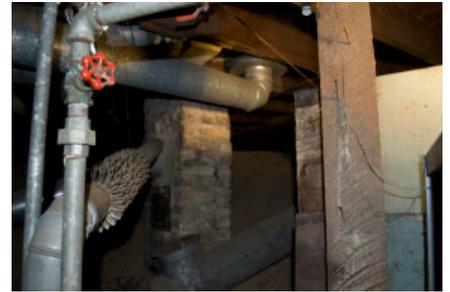
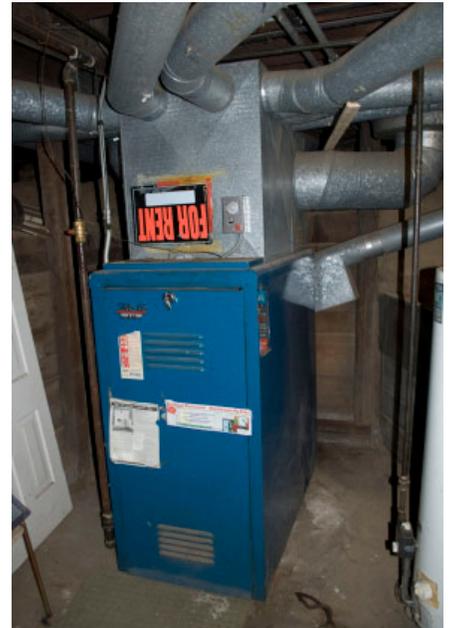
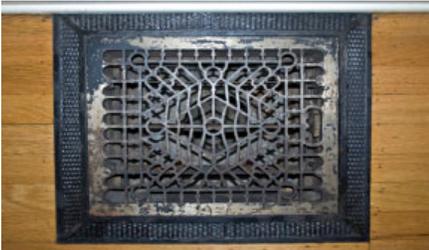
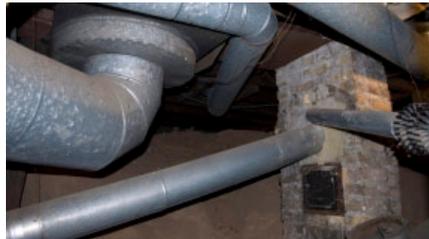
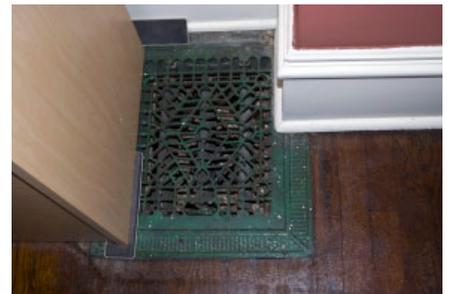
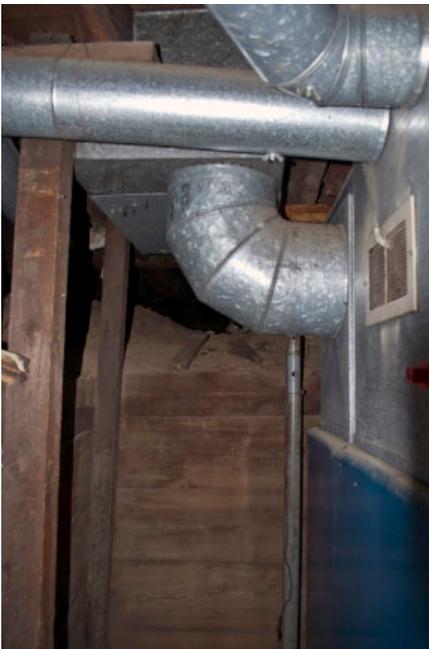
**SECTION 24: HVAC**

The HVAC system is in reasonably good shape. The forced air furnace and ducting is not original to the house. The decorative floor register covers are historic in appearance and are in good shape. Retaining this general heating system seems to be quite appropriate for the future. The furnace proper needs thorough evaluation to estimate its life expectancy. As a separate cost, it would be wise to anticipate that expense and plan for it. A new furnace purchase in the future would presumably include a high efficiency, energy saving model that would, of course, save on utility costs for the Society.

- Inspect existing furnace system and provide evaluation report.
- Make modifications for any code or warranty matters.
- Offer strategies for future cost savings.
- Ventilation, AC, dehumidifiers, insulation, etc.

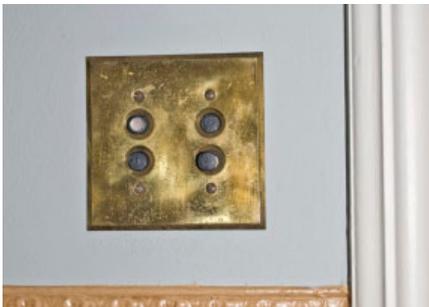
**ELECTRICAL SURVEY: November 1, 2010**

On November 1, 2010 an initial, informal, professional survey was conducted at the Beulah Brinton House in regards to the conditions of the existing electrical wiring. Anthony Schmidt, Service Manager of Roman Electric Co. Inc., evaluated the wiring in the basement and suggested his opinions as follows:

The existing circuit box consists of two service boxes. Anthony recommends consolidating all the wiring into one circuit box. The electric panel is 100 amps. It is the opinion of Anthony that 100 amps is sufficient for the type and use of the Beulah Brinton House. No additional power is necessary under current circumstances. Anthony assessed the wiring in the basement and found that there is both BX wiring and conduit fed throughout the house. Anthony observed that the installation of the wiring appeared not to be professionally done but it was installed correctly and safely. Anthony also mentioned that the BX wiring and conduit were safe and grounded. Recommendations from today's observations by Anthony were to consolidate the circuit board into one panel box, install two grounding rods, and establish a water ground. When asked for recommendations for HVAC professionals to refer to when addressing the heating for the Beulah Brinton House, Anthony recommended Burant Heating, and Burlington Heating.

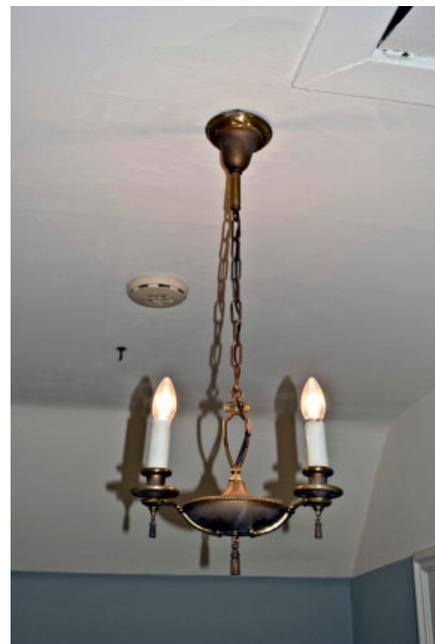
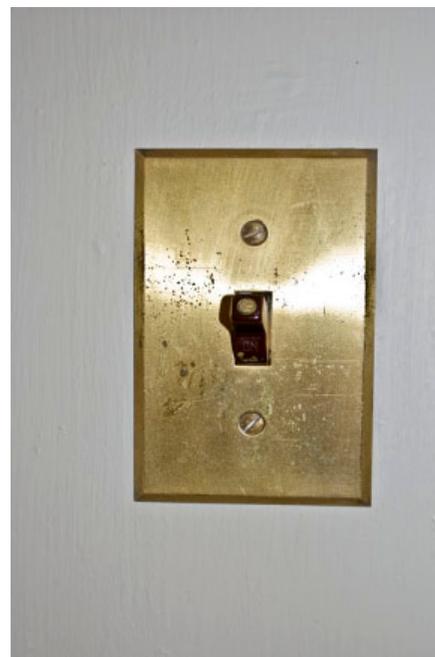
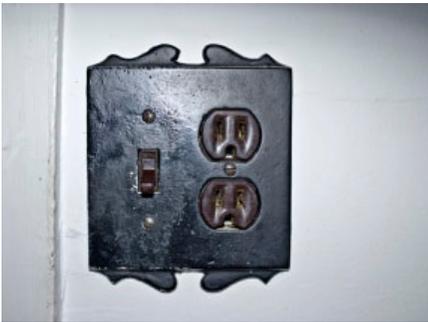
Anthony pointed out that the outlets need to be replaced due to code issues. Because the outlets are located in the kitchen, they need to be GFI outlets (which have localized circuit breakers). If there are plans to use the kitchen on a frequent basis it needs to be rewired. The feed of 100 amps from the electrical box is sufficient, but Anthony recommended running a new line (with it's own circuit) to the kitchen. The light fixtures seem to be from the 70's or 80's era.

The outlets need to be replaced with GFI outlets. One of the existing outlets is a GFI outlet though.

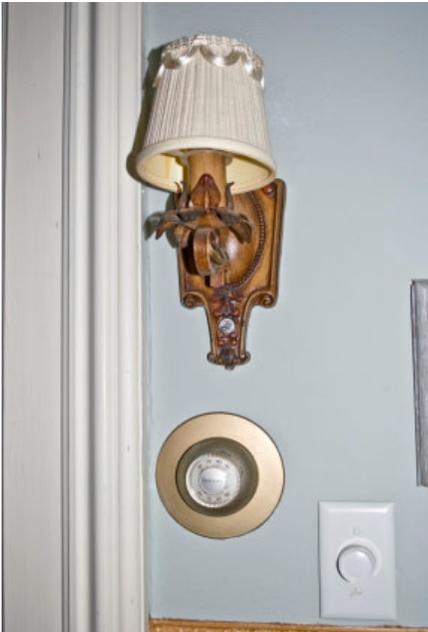
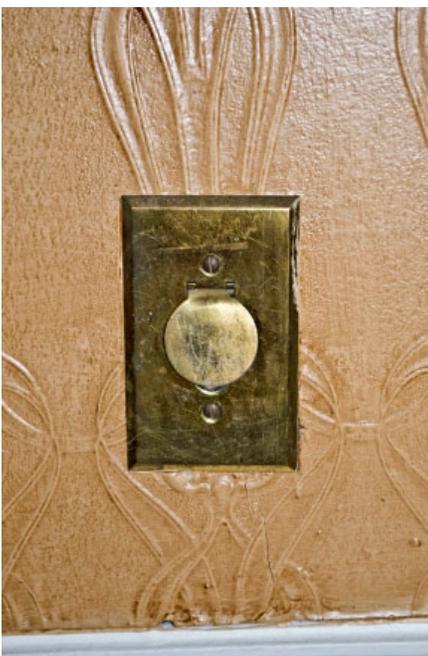
The issues noted with the electrical outlets are not fire hazards and do not need to be addressed immediately. They also should not present problems with basic electrical appliances (meaning they won't mess up a TV or something if it is plugged into the outlets). Bullet point list of general remarks for the interior of the house:

- Overall in good shape
- No immediate/threatening issues that need to be addressed
- No immediate repairs necessary
- Fix the reverse polarities problems in the outlets
- Ground the outlets
- Replace outlets in kitchen/bathrooms with GFI outlets
- Consolidate the service panel
- Update the grounding on the house itself (ground the house)
- Add a new line with its own circuit to the office
- Add a new line with its own circuit to the kitchen
- Restore or replace the outlets
- Restore or replace the light fixtures
- When restoring or replacing light fixtures it is necessary to add splice-boxes in the ceiling to help prevent electrical fires – note those boxes typically run \$320 per fixture
- Possible add outlets to each room depending on use for room
- Consider adding new/extra lighting if the house will be used frequently (depending on its use)

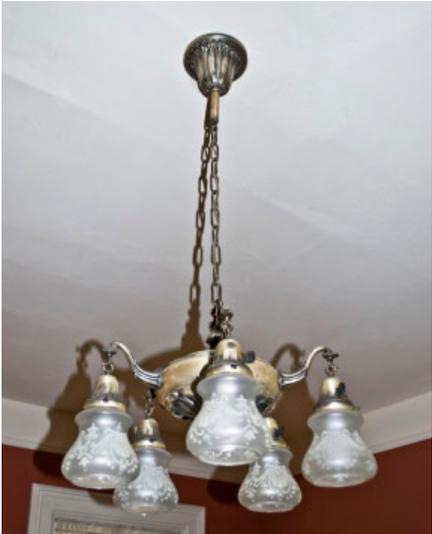
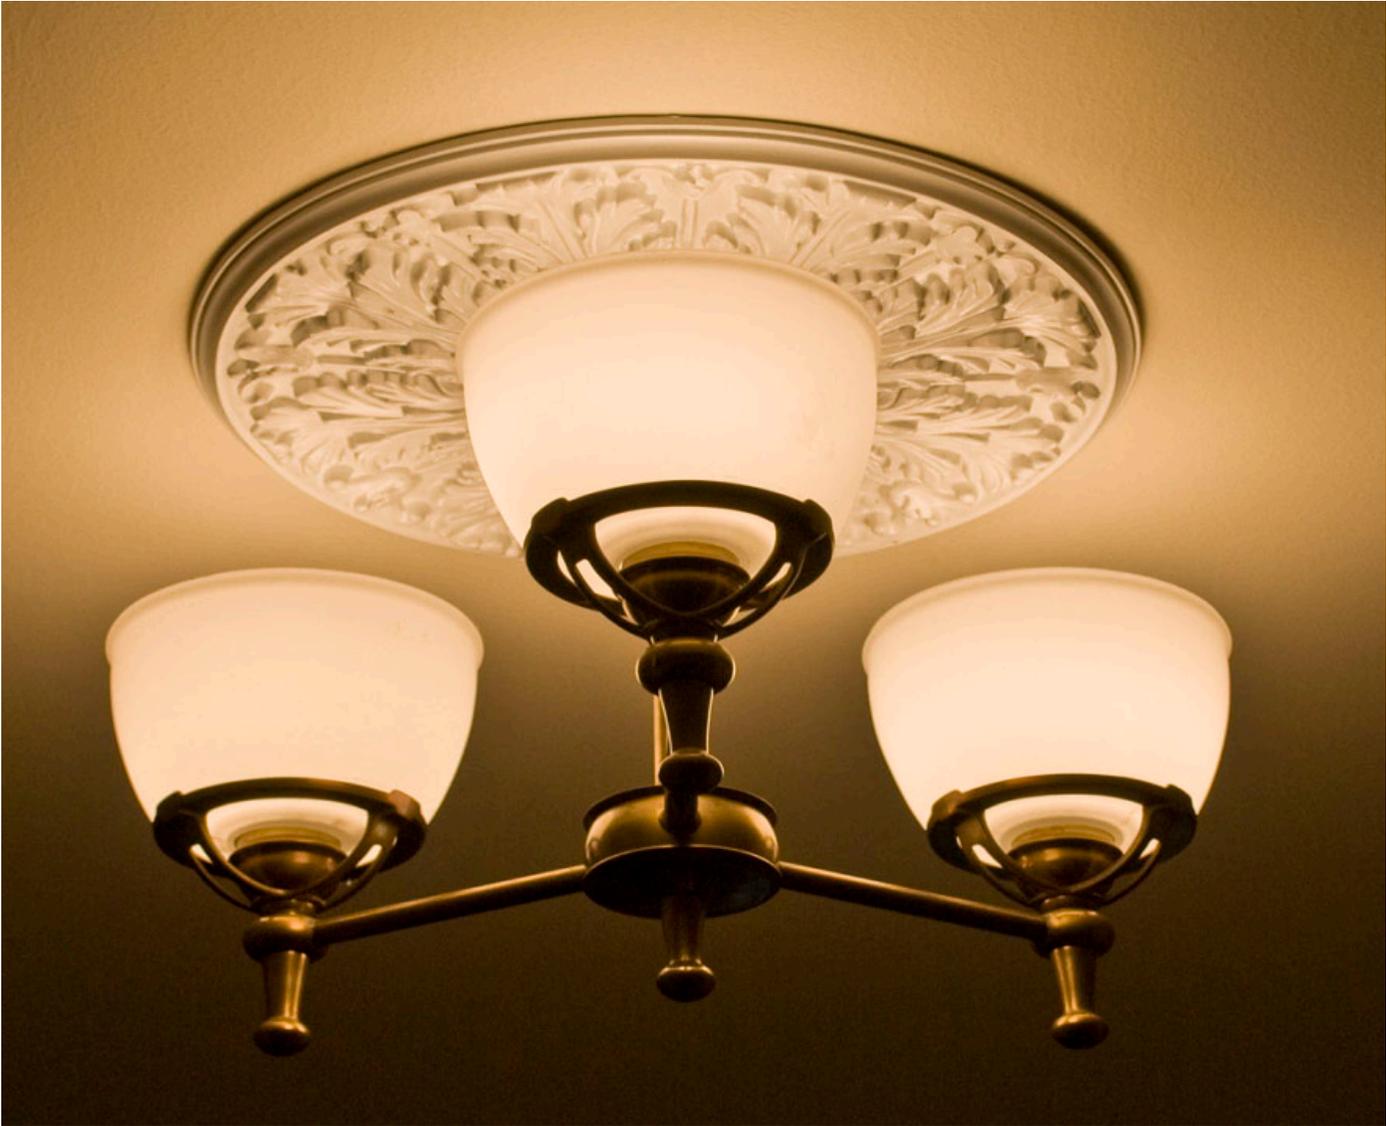
The light fixtures seems to be working well throughout the house. Basic cleaning may be necessary but it doesn't seem as though any major rewiring needs to happen. Face plates and switch plates, if not original, seem to retain a historic appearance. some may need replacement. For the most part, the electric budget for wiring and code compliance should cover this matter. It is advisable though to carry a small allowance for possible fixture replacement in the future for new lights if the remodeling work of the bathroom and kitchen is done.

Light fixtures, face plates, switch plates..... \$1,500

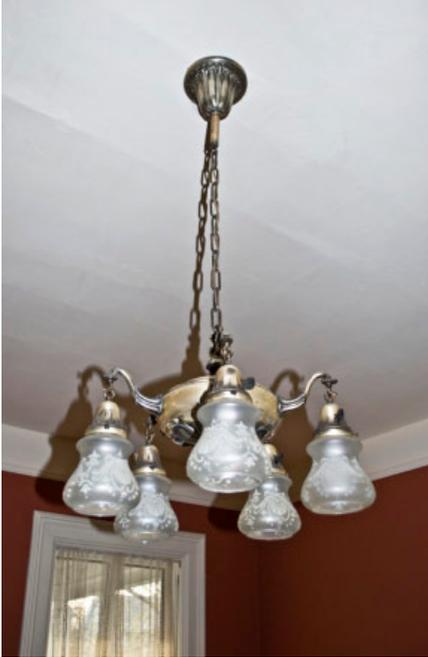
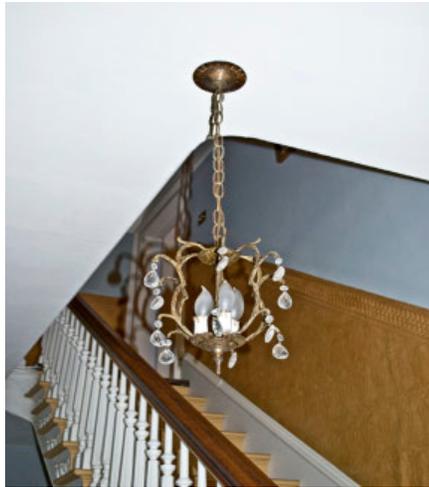
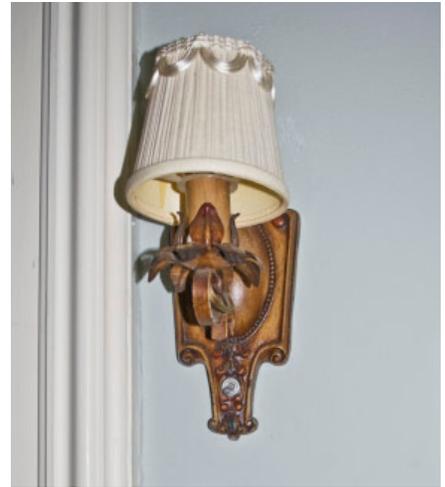
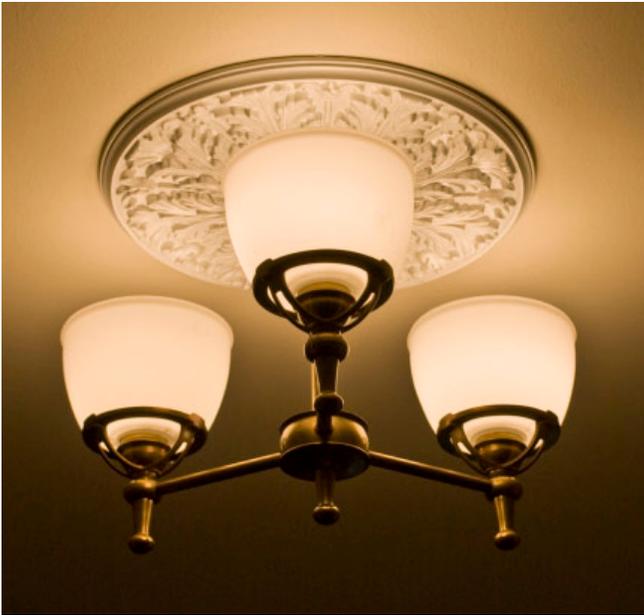
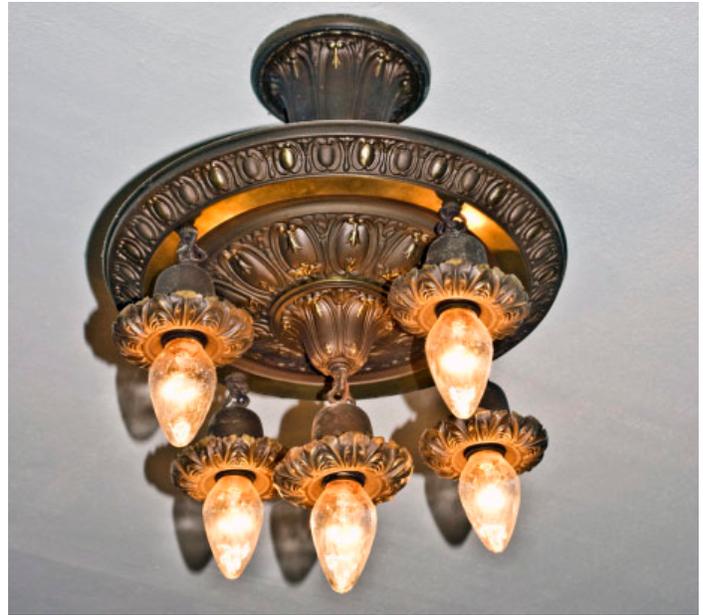
In general, the light fixtures on the second floor can be utilitarian in nature. The important, and perhaps expensive period fixtures should be on the first floor where the general public will be. The main point is that appropriate, code compliant wiring be completed, and that cost is included in the electric contractor's bid on the preceding page. For now, we should retain an allowance for possible light fixture replacement in the future.

Second Floor light fixtures allowance .....\$1000

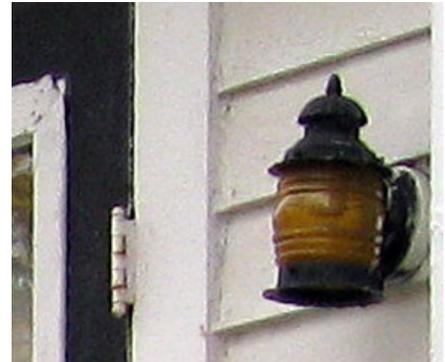
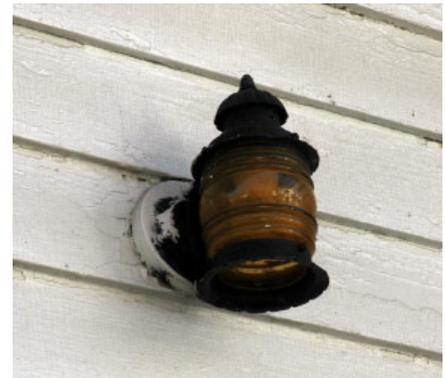
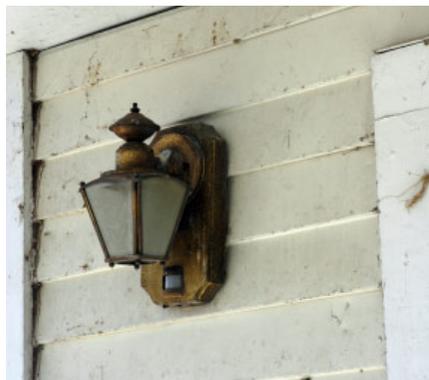
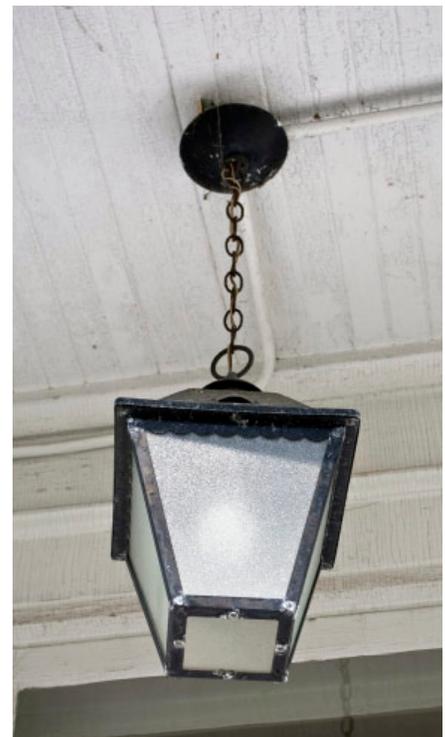
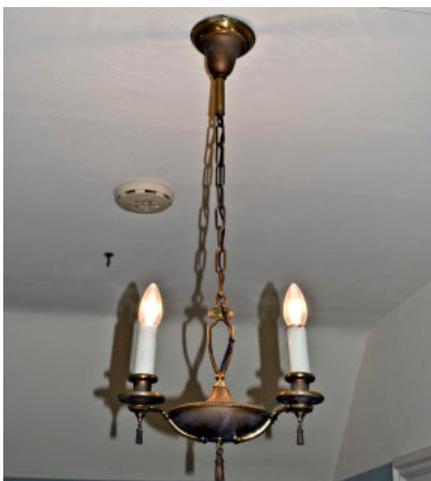
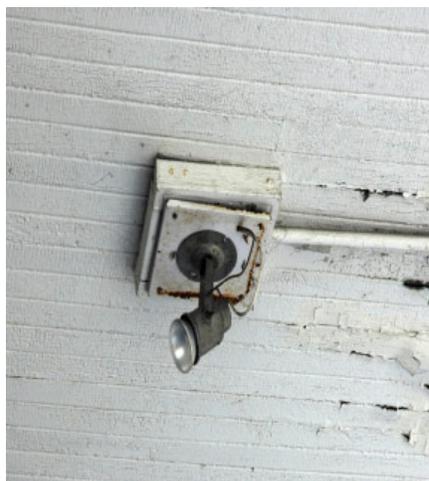
The light fixture on the front entrance appears to be from the 70's era. If considering the Brinton House as a reception venue it is recommended to add exterior lighting (either attached to the house or on light posts near the sidewalk) to accommodate for such events on the lawn. It also is recommended to add electrical outlets outside. If considering showcasing the Beulah Brinton House with night lighting recommendations were made by Anthony to install LED up-lights on the exterior of the house. These would be located in places to showcase areas of architectural interest. However, general recommendations would be to install 2 to 3 up-lights per façade, offset from the façade by about 1 to 8 feet. The LED lights are low energy consuming and long lasting lights (virtually never have to replace them unless intentional (vandalism) damage is made. They virtually never need replacement unless intentionally damaged. They may also offer an opportunity to receive subsidies or rebates from electrical companies. Anthony recommended contacting the company "Focus on Energy" to find out more about subsidies that may be available.

Exterior lights allowance.....\$1,500
